Clapp Memorial Library

Conditions Assessment

A review of existing conditions
and prioritized recommendations for treatment
of the historic Clapp Memorial Library

July 29, 2015

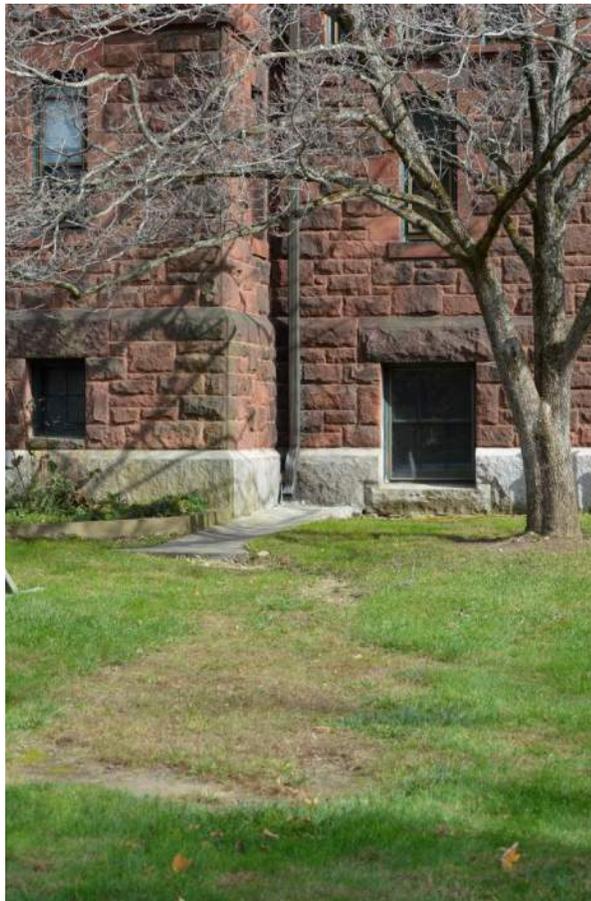
Directing water runoff, primarily from roof surfaces, is critical to the health of both interior and exterior surfaces and finishes. Copper gutters and associated downspouts are in place along the roof eaves. Many of the downspouts are booted into an underground drainage system of unknown design and outlet. Two downspouts on either side of the front entrance gable are not directed to underground drainage and the runoff flows over the lawn and access walk leaving debris and potential icing in its path. Erosion of the soil at the base of the exterior walls has exposed the field stone foundation which is now vulnerable to water infiltration. Copper gutters at the valley between the main gable entrance element and the north and south wings have been damaged due to heavy ice and snow fall in recent years.

Figure 9 - Roof drainage systems empty across the lawn and the north entrance walk.

- Repair and provide adequate support for the copper gutters at the front valleys.
- Investigate existing underground drainage systems to insure that they are running freely to daylight or to a working yard drain.
- Regrade areas adjacent to the building to achieve positive drainage away from the building.
- Redirect the front leaders underground to yard drains beyond the north-south access walk.
- Insure that the linear drain at the base of the entrance ramp is clear of debris on a regular basis. Snake the drain line on a yearly basis to insure free drainage.
- Upgrade striping and signage at the van accessible parking space.

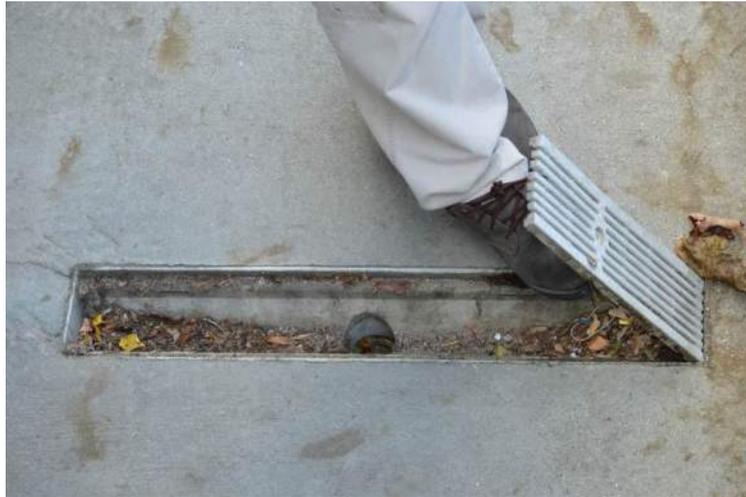
A linear drain at the base of the access ramp on the north east side of the building was designed to collect water running off the ramp and carry it to an outfall on the east side of the ramp. This system may be undersized as water does not always drain away completely.

Figure 10 - A trench drain at the base of the entrance ramp requires vigilant cleaning to function properly.

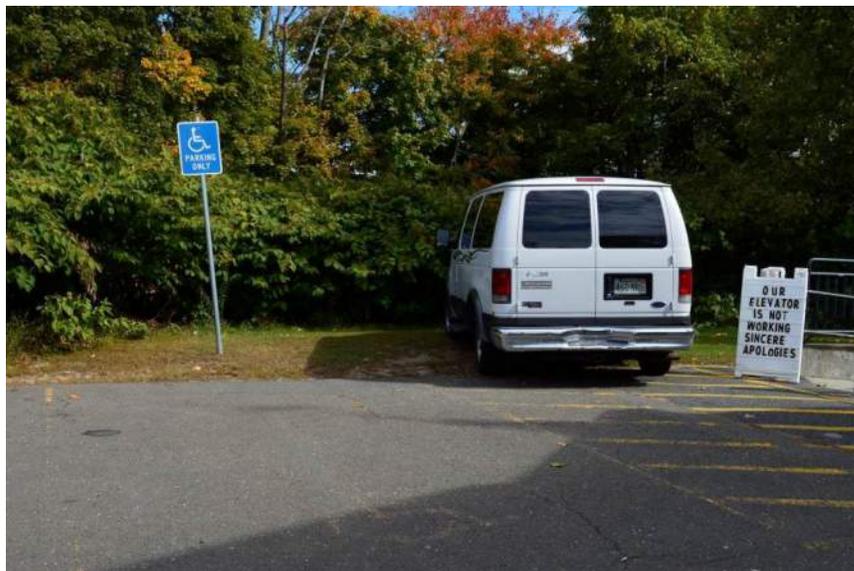
Exterior accessibility routes are no longer code compliant.

Figure 11 - Signage and striping should be upgraded for code compliance.

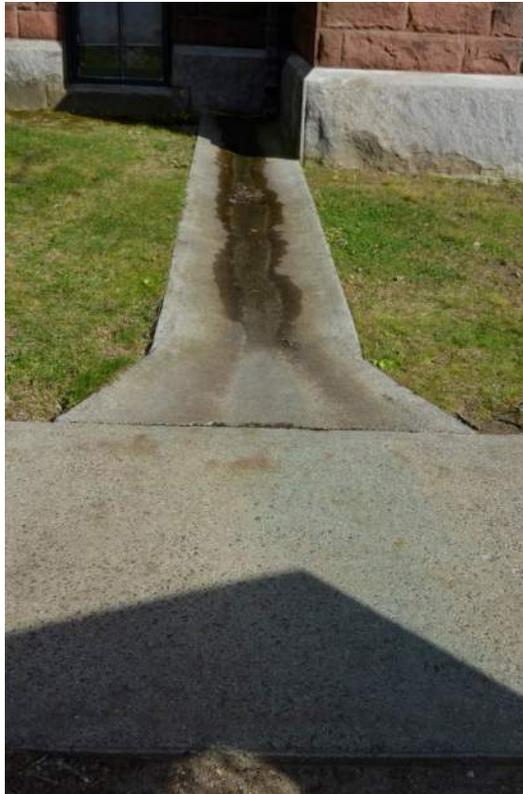
Figure 12 - Surface drainage should be channeled underground to eliminate runoff across walking surfaces.

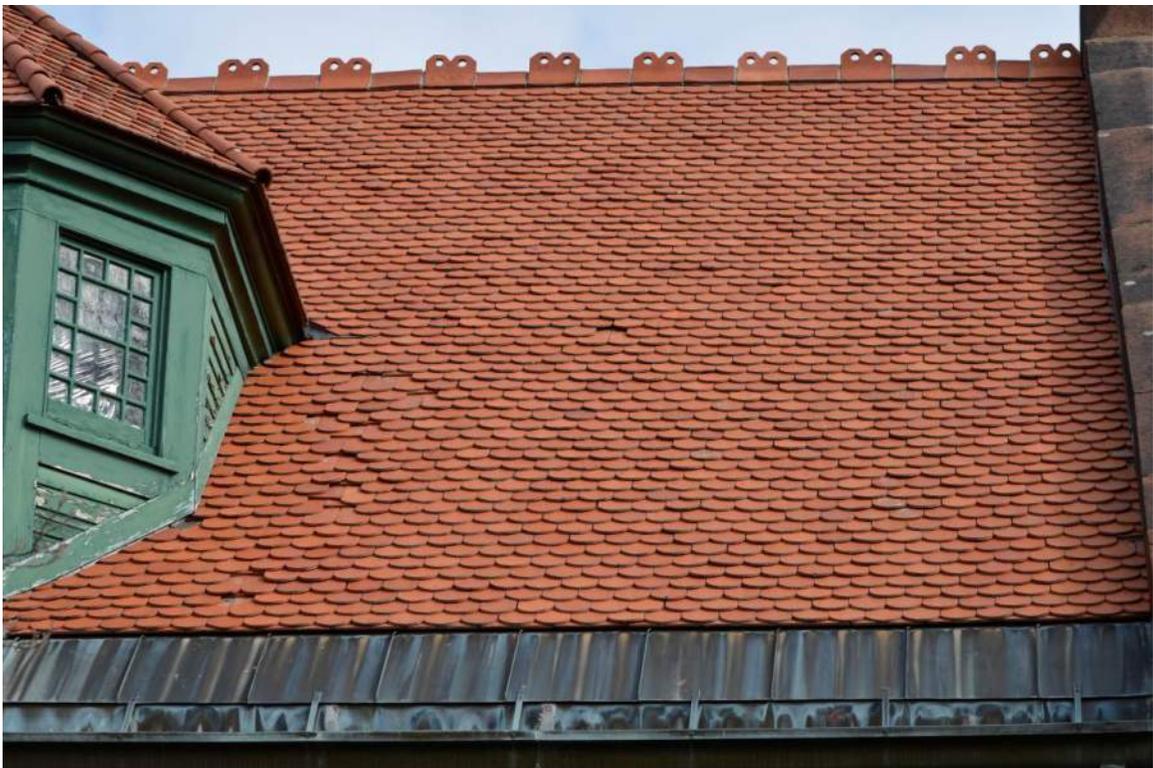
The *clay tiles* of the front roof system are in fair condition. There are many broken and/or missing pieces to be replaced. The *asphalt shingle* roofing on the rear of the building, installed in 1996, appears to be in good serviceable condition. Prior to the 1996 project, this roof was clad in clay tiles. Slate and clay tile make roofs water tight, not air tight. Asphalt shingle materials tend to last twenty years on older building stock because of the passive ventilation that characterizes such buildings is minimized. All *flashing assemblies* appear to be in good condition. Monitor this roof and anticipate replacement.

Figure 13 - Clay tile roof shingles are decorative and also fragile.

- Remove and replace broken clay tiles on the front roof of the building. Replacement should be performed with closely matching tiles. Some stock is found in the basement of the library. If more pieces are needed than available, salvage dealers should be contacted in an effort to find an exact match.

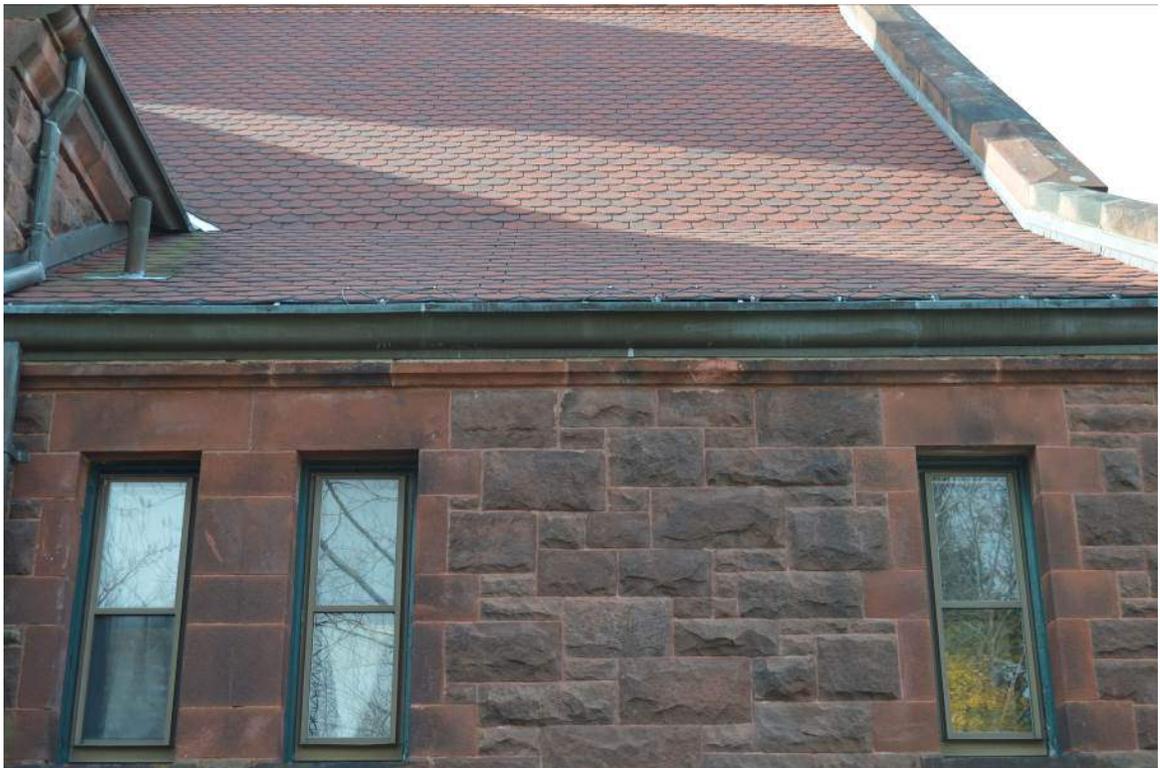
Figure 14 - The asphalt shingle roof on the rear of the building is a substitute for the original clay tile roof. This roof is 20 years old and will be in need of replacement in the next 10 years.

- Monitor the condition of the shingle roof once per quarter and after a major weather event. This portion of the roof is almost 20 years old. Replacement in the next 10 to 15 years should be planned.
- Inspect the metal flashings on a quarterly basis. While a major restoration of the roof took place less than twenty years ago, *flashing assemblies* should also be monitored and inspected regularly. When replacement is necessary, they should be replaced with new, 20 oz/sq' copper materials and 48 oz/sq' sheet lead. At the time of work, decking and wood blocking should be inspected for rot and replaced in kind. Ice and water shield is applied to the deck and sides of any protrusions that are to be covered with copper flashing materials. 30# felt paper should cover the membrane and act as a break between the sheet metal and ice and water membrane.

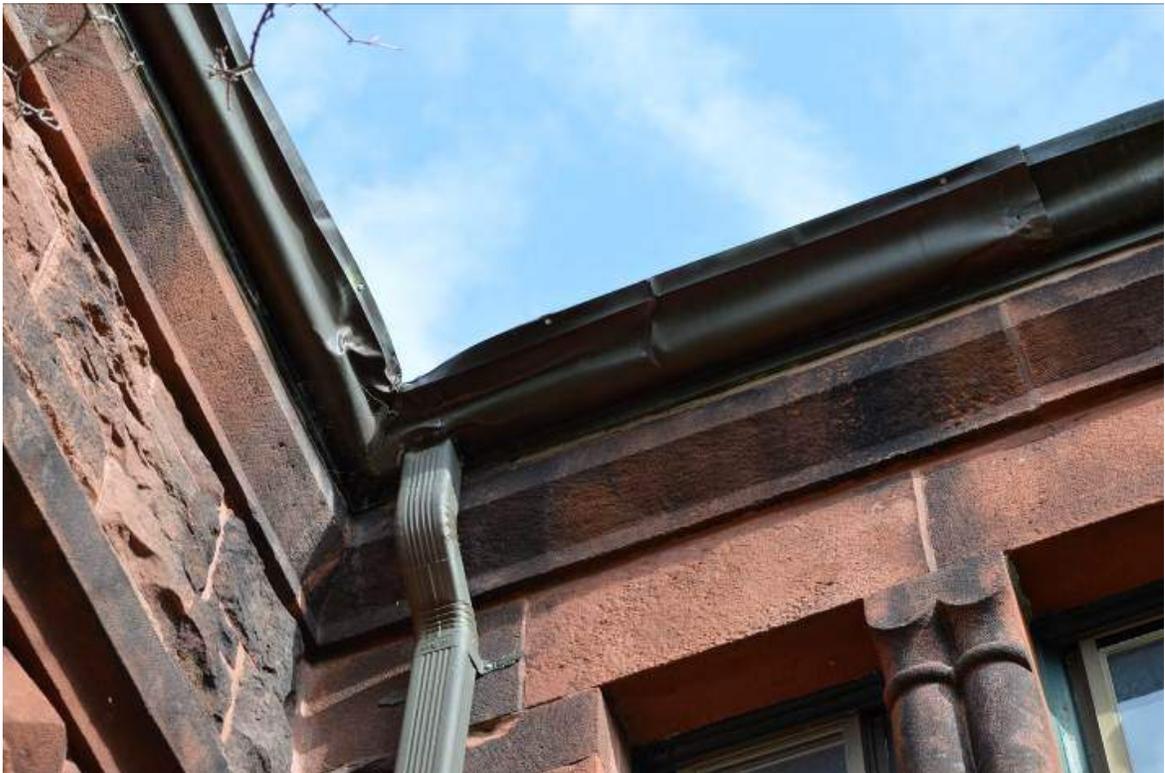
The *gutters and conductor pipes*, overall, are found to be in good condition. One section at the intersection of the gable entrance roof and the main roof on either side has been severely damaged by ice and must be replaced. When calculating drainage capabilities, one square inch of outlet opening is required for each 100 SF area of roof surface being drained. Hence, the outlets and conductor pipes are more than adequate to service the roof surface area.

Figure 15 - Copper gutters damaged by ice damming should be replaced.

- As recommended in the site drainage section, damaged gutter intersections should be replaced in kind.
- Copper wire strainers should be installed at each outlet and checked biannually.
- Clean the gutter troughs annually.

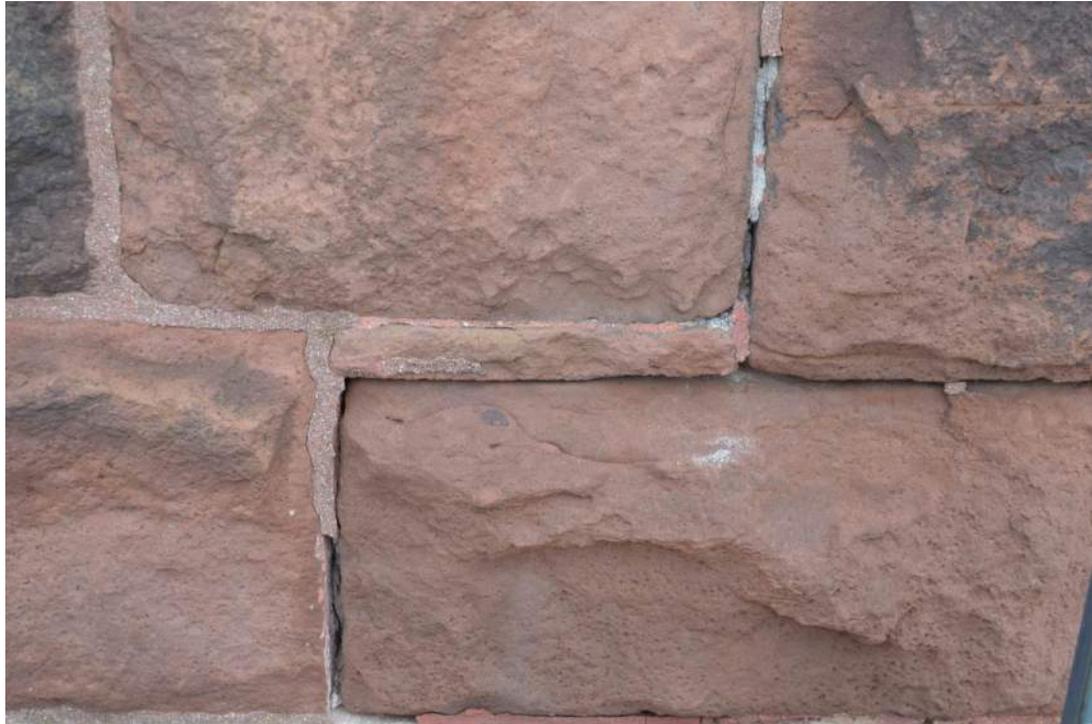
The *stone masonry* of the walls is in good overall condition with some localized issues that would be best described as fair. Some repointing is needed, and cracks are visible that warrant further investigation.

Figure 16 - Past repointing is visible as are stress cracks due to settlement. Areas requiring repointing are limited but occur throughout the facade.

With respect to the *stone walls* of the building, there are cracks in specific locations that may be directly attributed to building settlement. Tell-tale gauges should be installed and monitored through four seasonal changes to detect any movement. Each week the gauges are manually inspected and findings recorded. For the sake of continuity and consistency, every effort should be made to minimize the number of individuals performing the inspections.

- Empty or failing mortar joints should be repointed as needed. The mortar should be tested for composition and appropriate recipe specified for repointing according to ASTM C-1324-03 Standard Test Method for Examination & Analysis of Hardened Masonry Mortar by a qualified materials conservator. The material must also be sympathetic in texture, color, strength and appearance to that in adjoining areas.

- Monitor the stress cracks and joints in the façade that are potentially related to building movement.

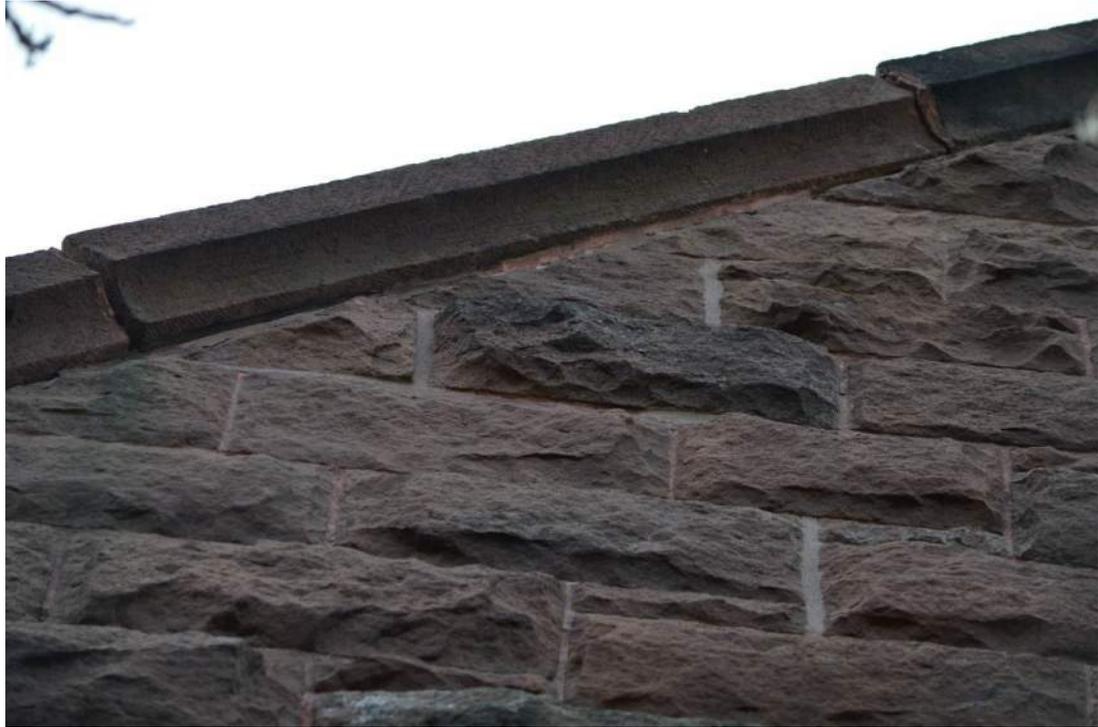
At the rear of the building there are large coping stones at the gable roof ends which have become displaced. Throughout the façade, the joints in the coping were observed to be entry points for precipitation and the cause of saturation within the wall system.

Figure 17 - Displaced coping stones on the gable ends should be reset and re-mortared.

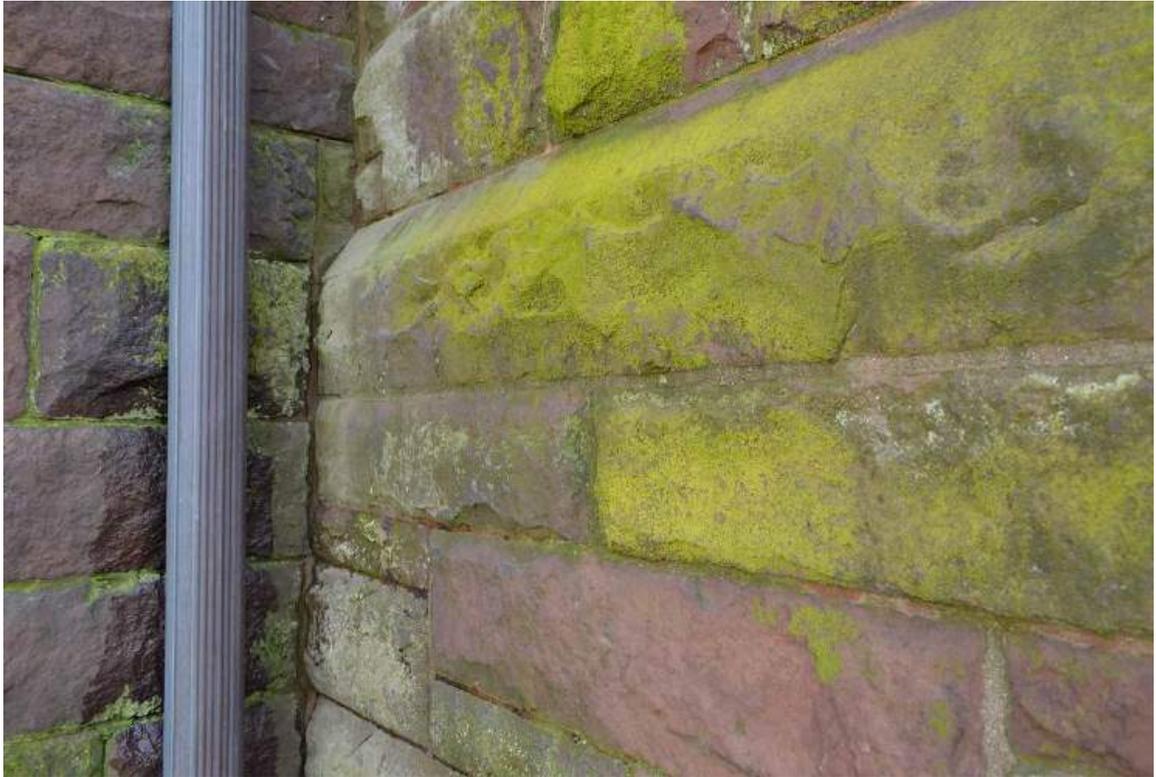
Figure 18 - Biological growth should be removed from the building using the gentlest possible means.

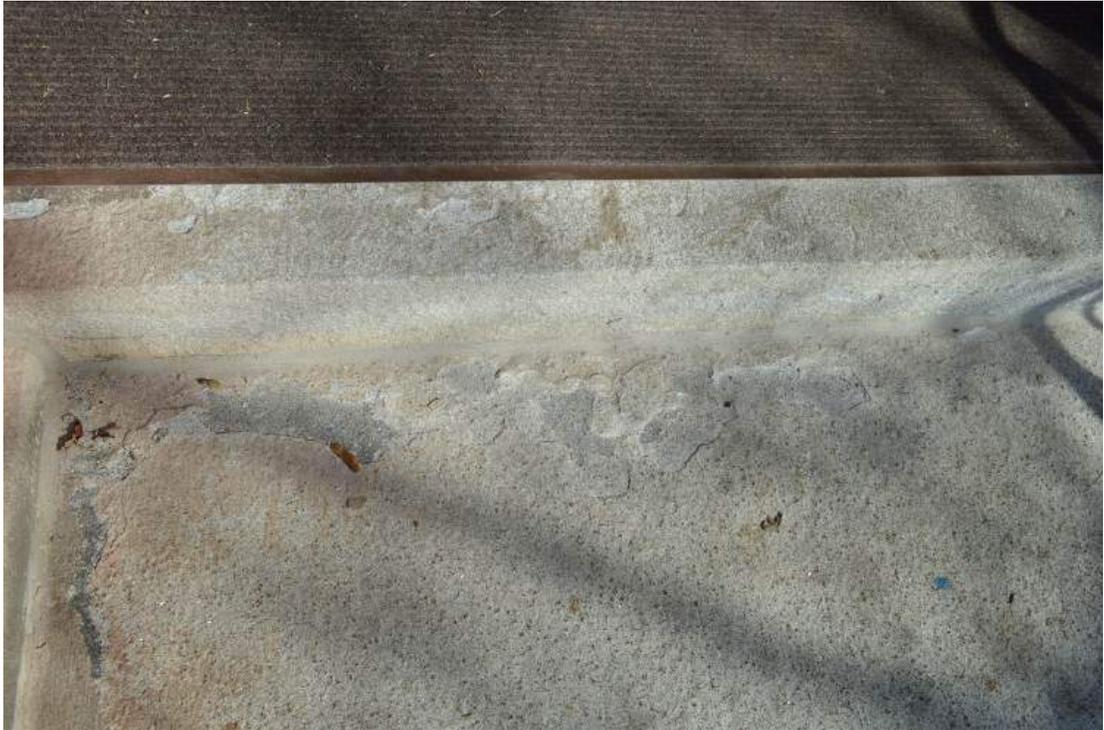
Figure 19 - Sugaring of the granite steps is due to the use of calcium chloride which should be avoided.

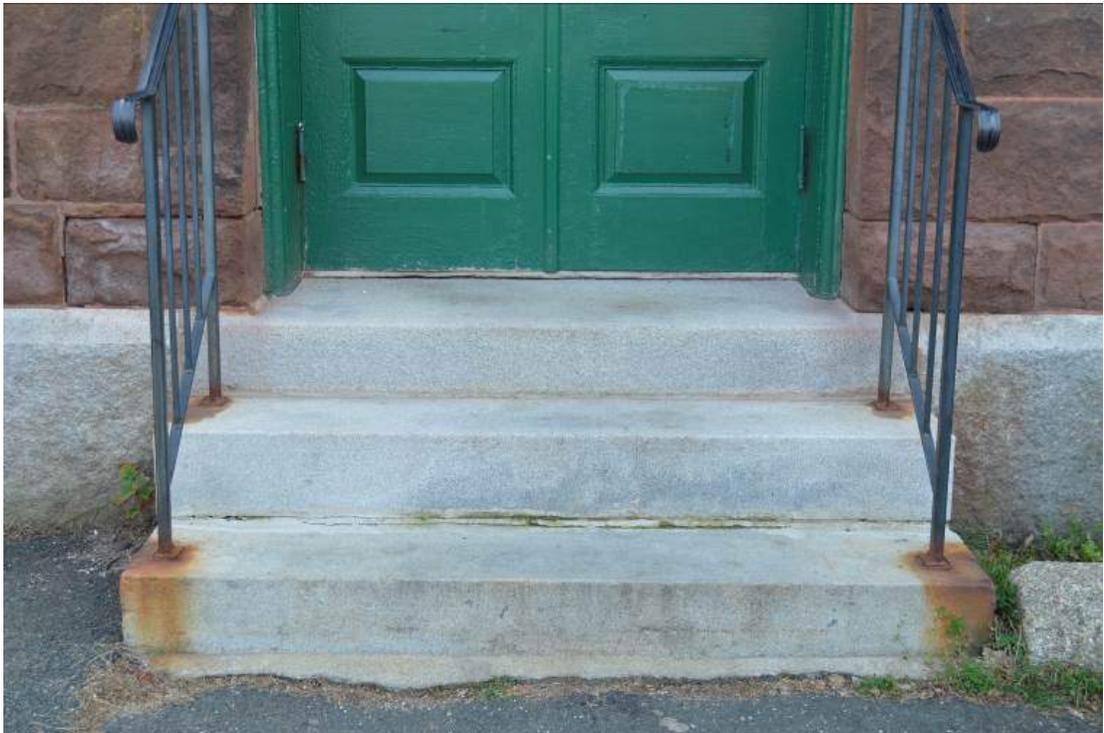
Figure 20 - Rust should be removed from wrought iron railings to prevent spalling of the stone.

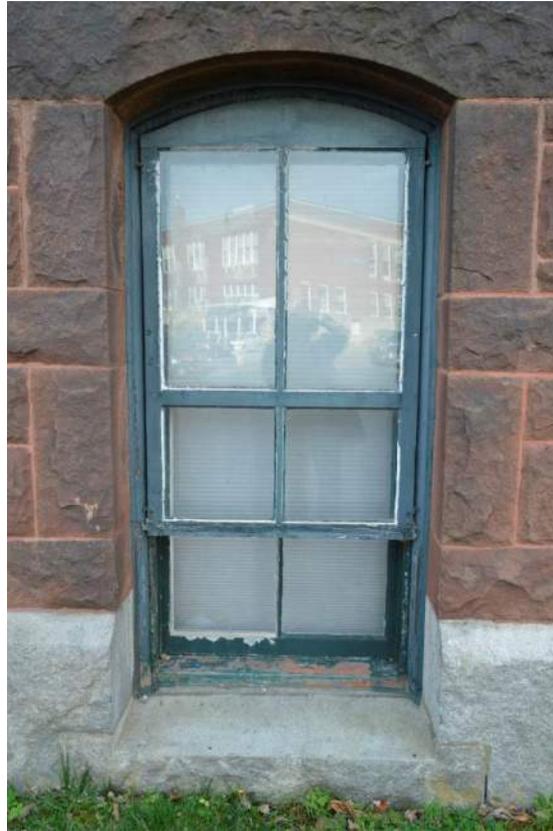
The *window* condition ranges from fair to very poor. In the tower, for instance, there is a window missing. Nearby, a storm window is missing. There are varying degrees of loss of coatings (paint, varnish and stain) on the doors and windows. Wood rot is also detected throughout due to failed paint coatings.

Figure 21 - Wood window sash and surrounding framing and trim should be reglazed and repainted.

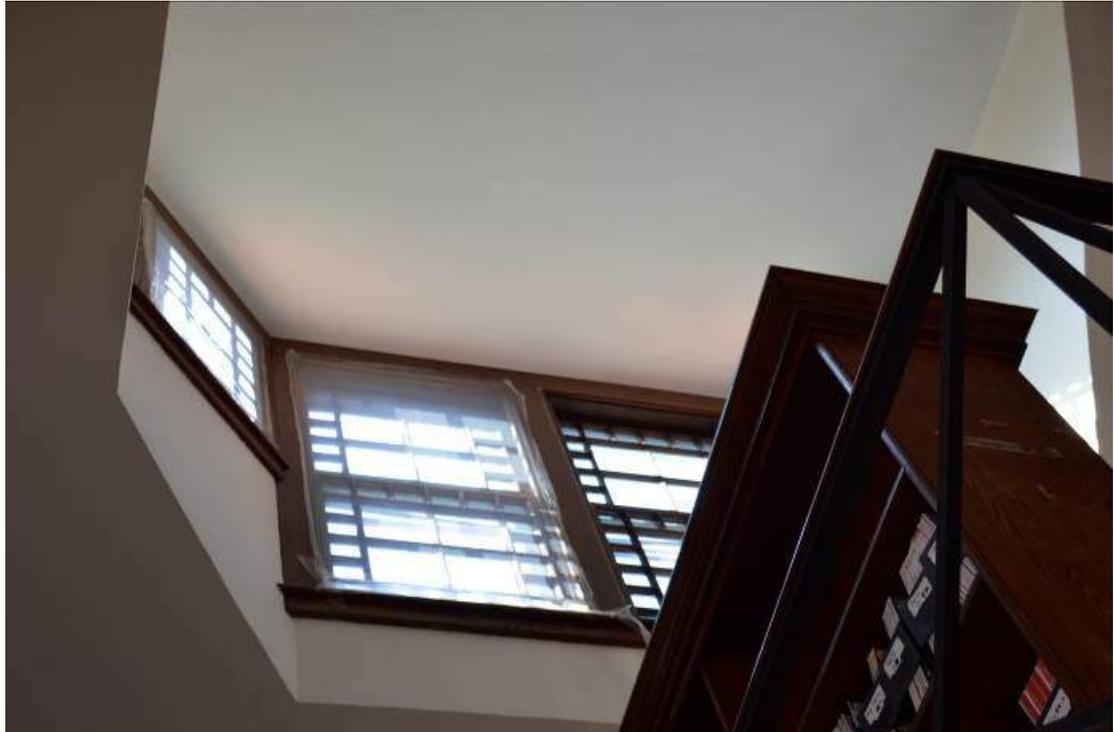
Moisture, which becomes trapped between the layers of glass, will condense on the colder, outer original window, and has the potential to cause deterioration. The correct approach to interior storm window use requires the creation of a seal on the interior storm while allowing some vapor to escape around the prime window. In actual practice, the creation of such a durable, airtight seal is difficult and there is no protection of the historic original windows from the elements. This system requires a level of vigilance with respect to inspection and upkeep that is not conducive to institutions that have difficulty maintaining their buildings.

Figure 22 - Interior storm window treatments should be avoided as condensation will occur on the coldest layer, in this case the wood window itself, causing damage to the wood.

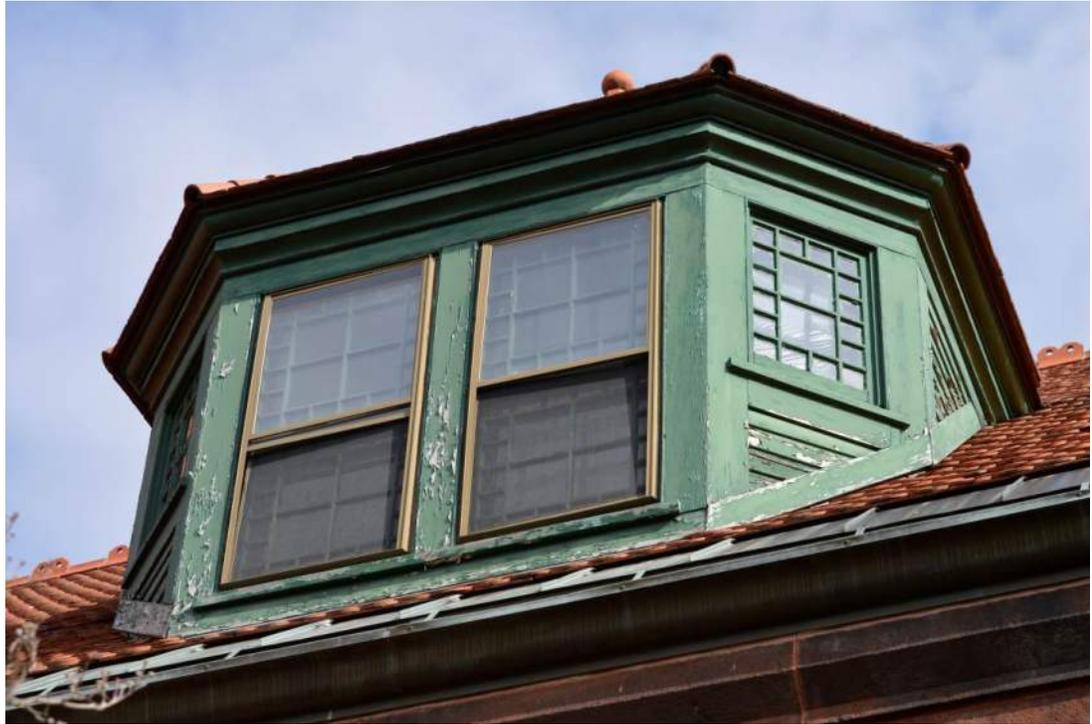
The *architectural woodwork* of the building is characterized by peeling paint. Fascia, soffit, frieze, brackets, panels, moldings and other wood members of the tower, dormers, and door/window surrounds must be scraped, sanded, primed, and painted. All actions that involve the handling of wood must be performed in full compliance with Massachusetts' 'De-leading and Lead-Safe Renovation Regulation,' and the EPA's Renovation, Repair and Painting (RRP) regulations by a licensed, 'Lead Safe Renovator' if testing detects the presence of lead.

Figure 23 - Wood gable elements require repair and repainting.

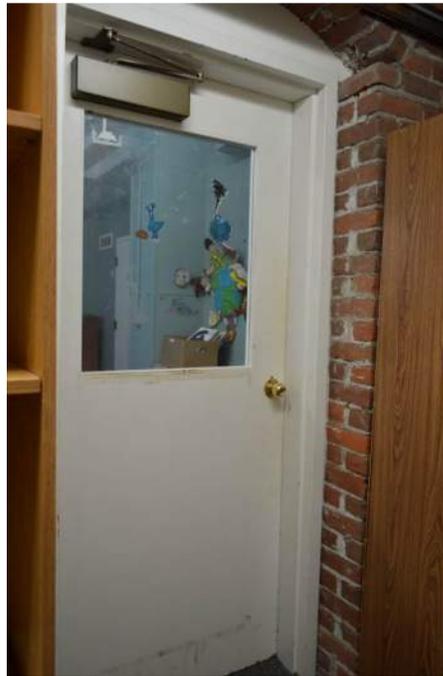
Figure 24 - Door hardware along accessible routes should be code compliant for universal access. In this case a level handle lockset is appropriate.

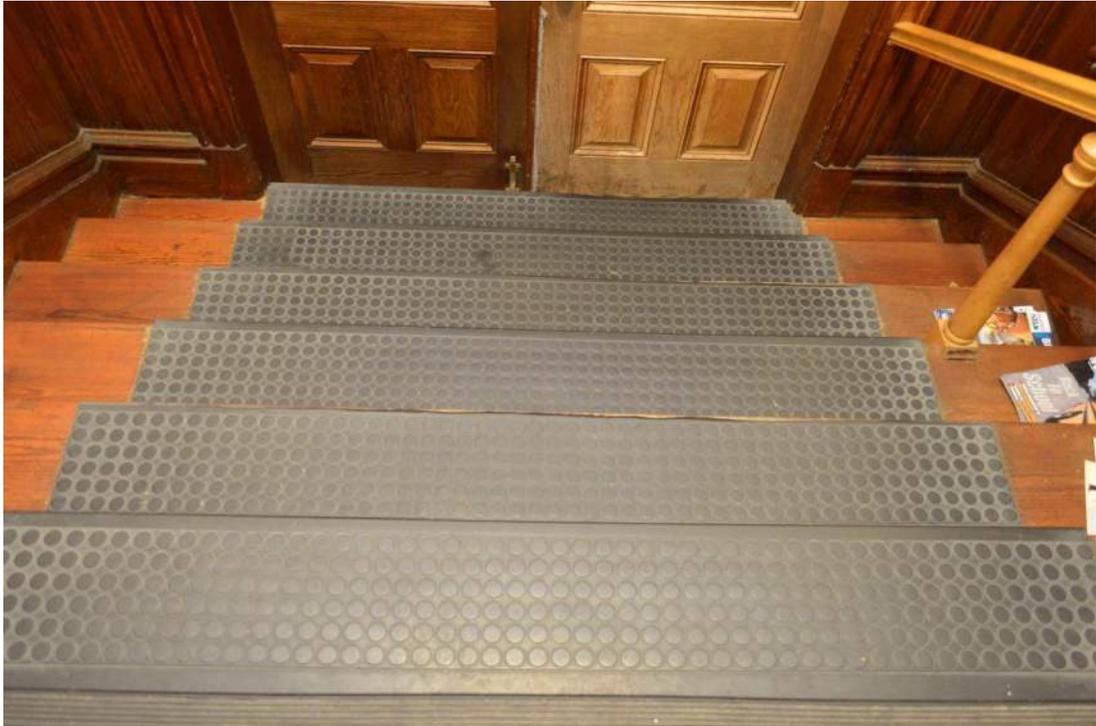
Figure 25 - There is no landing at the base of the front entrance stairs leading to a hazardous condition.

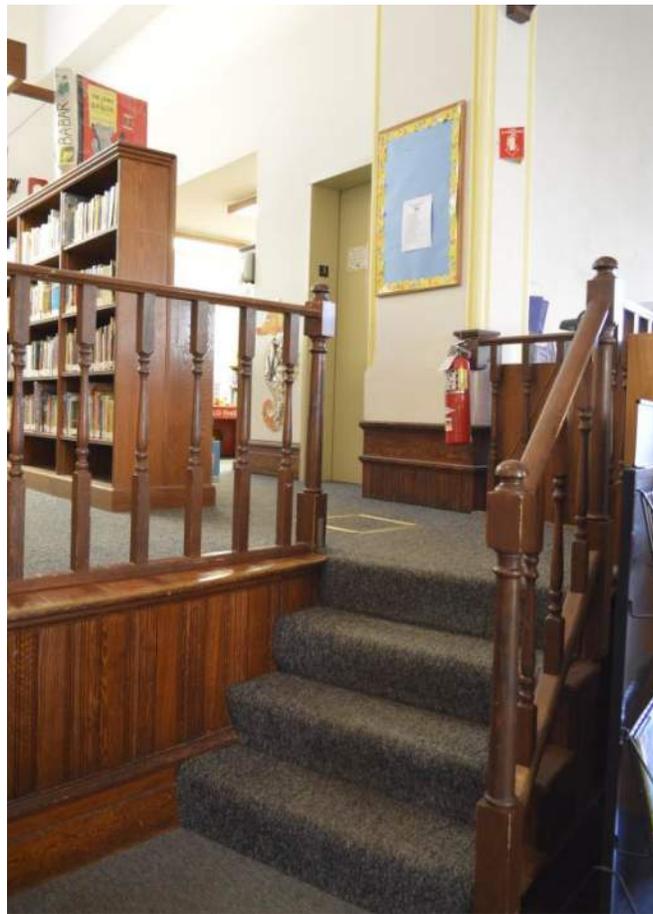
Figure 26 - Stairs to the Children's Reading Area should be rebuilt to have a code compliant rise and run.

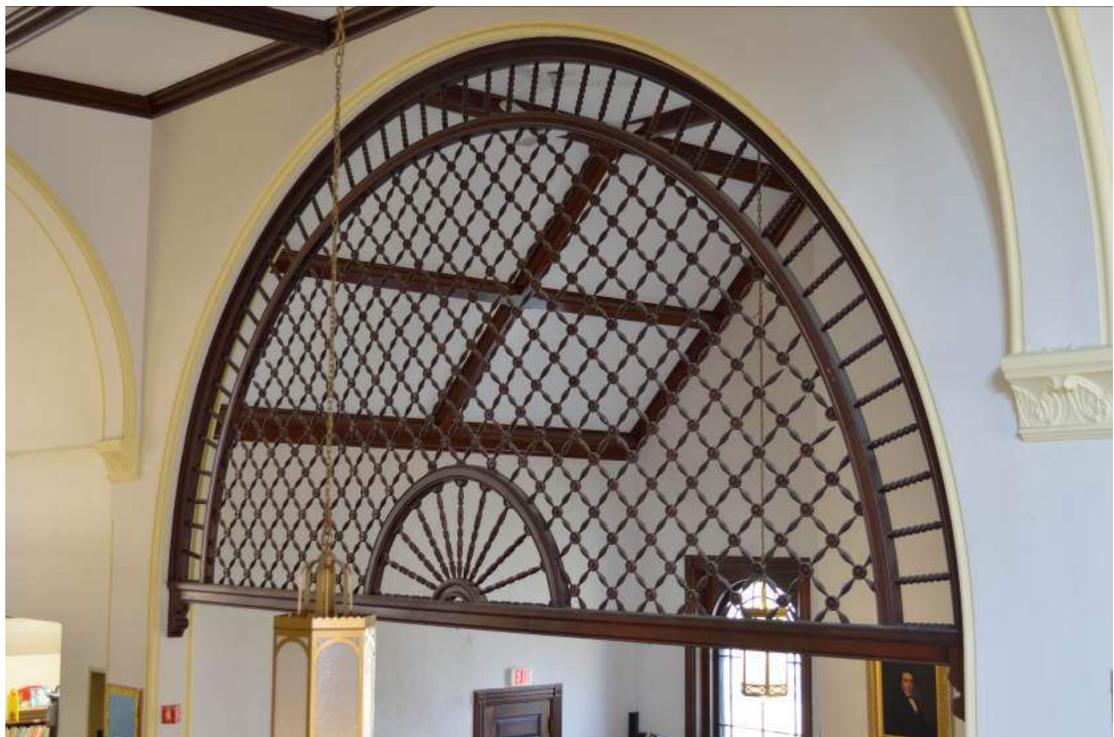
Figure 27 - The decorative screen shows signs of bowing but is not in danger of failure.

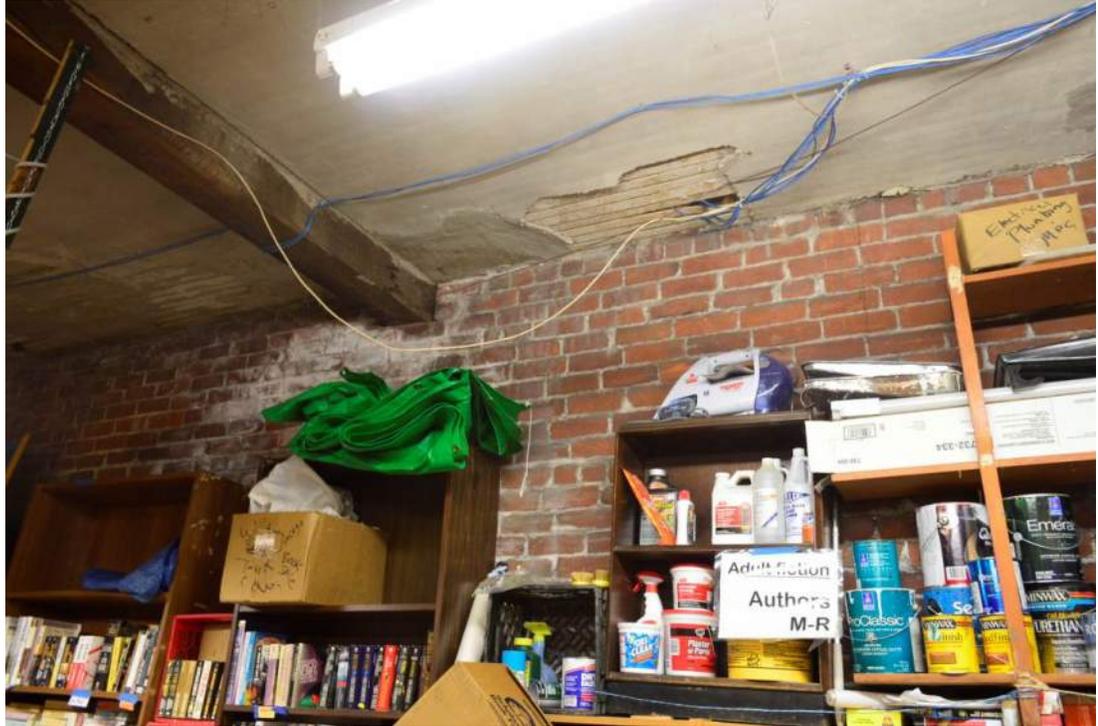
Figure 28 - The failing lath and plaster ceiling should be removed and a fire rated ceiling finish installed.

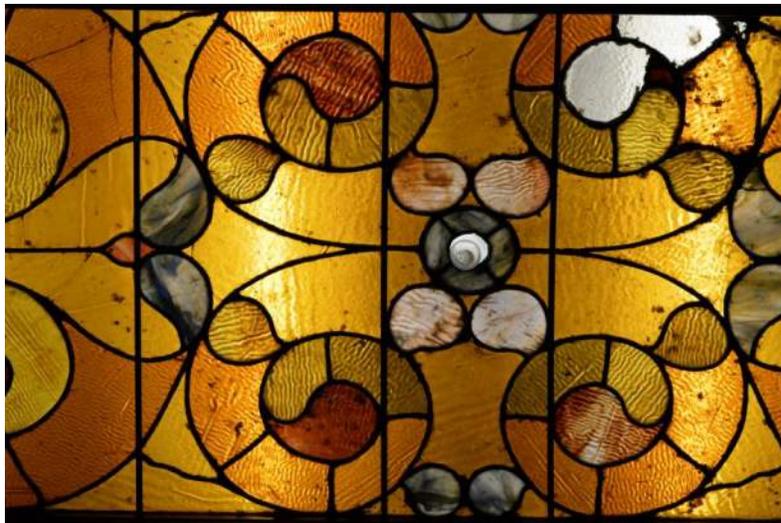
Figure 30 - The central lay lite is slightly damaged. Protective glazing should be installed on the underside.

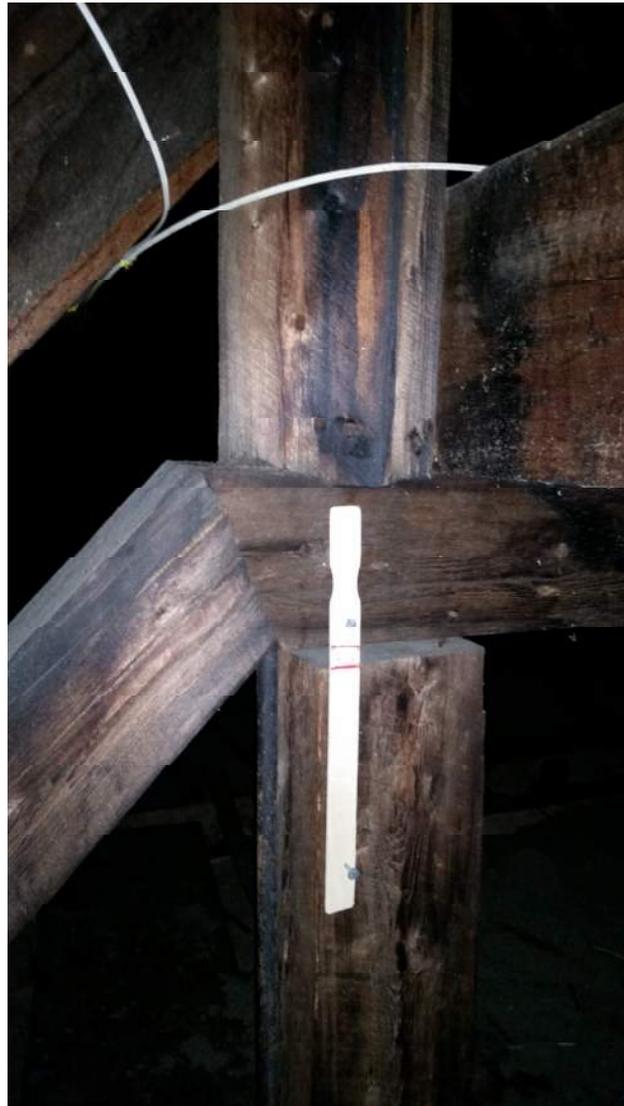
Figure 31 - A telltale has been installed on the King Post truss in the attic to measure movement of the joint.

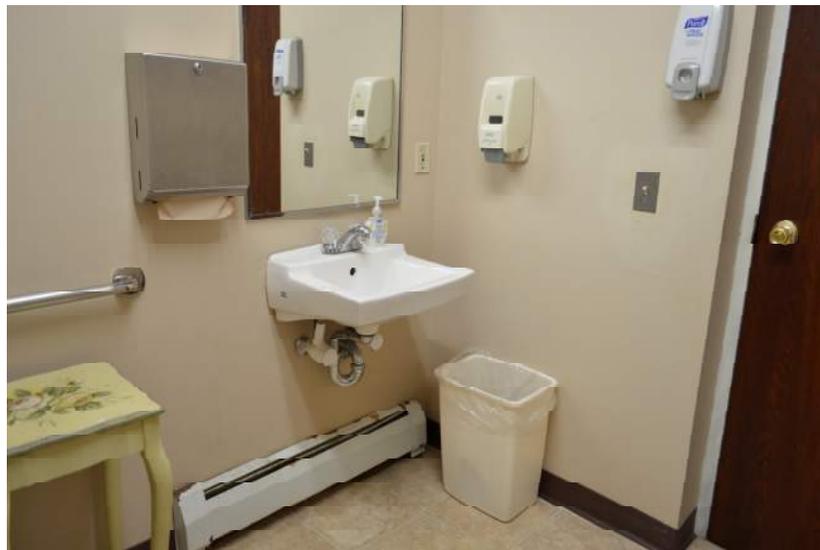
Figure 32 - The heating unit should be replaced, under sink piping should be insulated and dispensers should be mounted at code compliant heights.

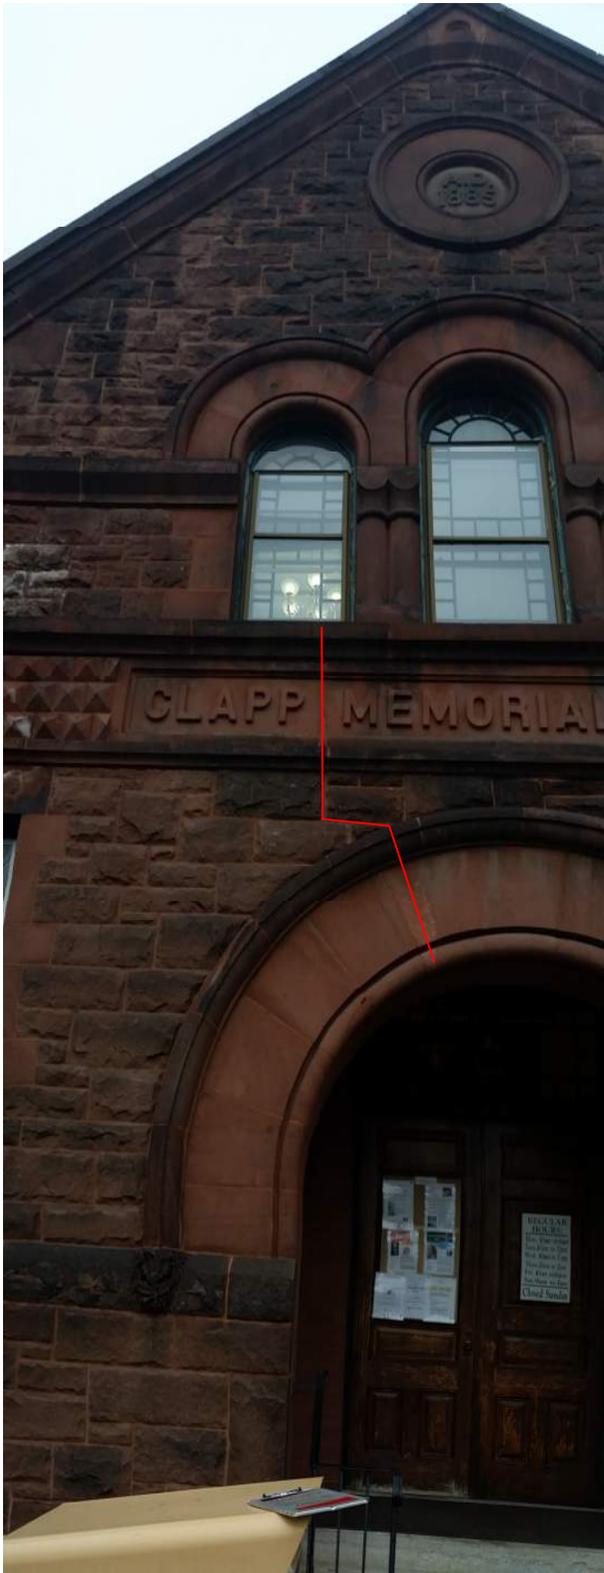
*Photo 3: West Façade
Note: Thermal expansion cracking in
arch stones, progressing vertically
upward.
Cracking progresses diagonally up
to coping stones.*

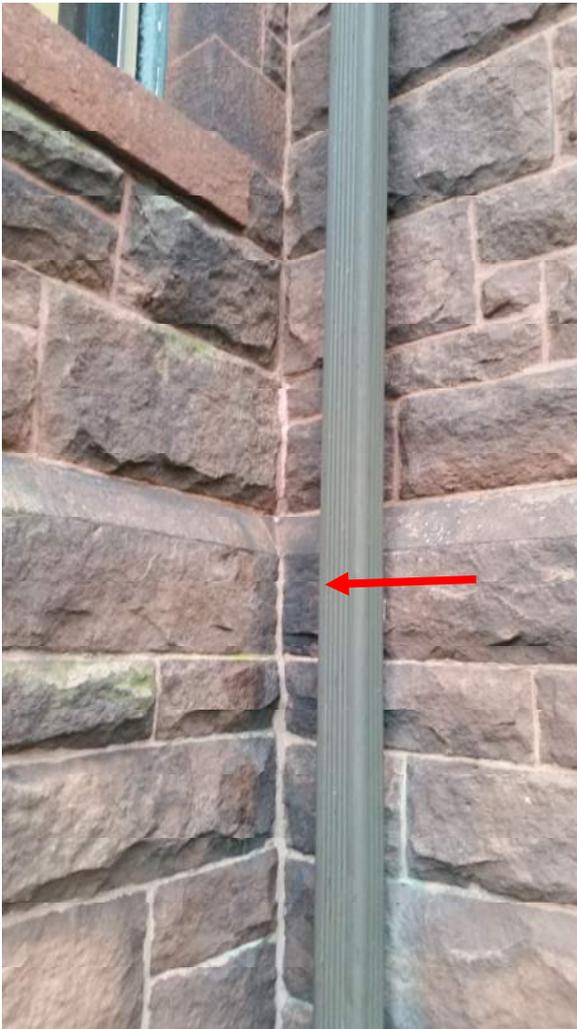
*Photo 4: South Interior Corner Near Front Entrance
Note past joint repairs on interior corner
(sign of past expansion crack repairs)*

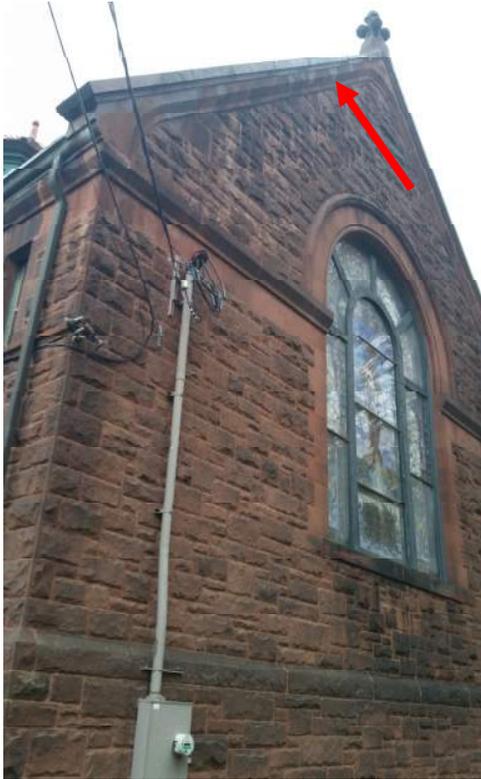
*Photos 5&6: South Façade
Note water weeping from coping
stone joints*

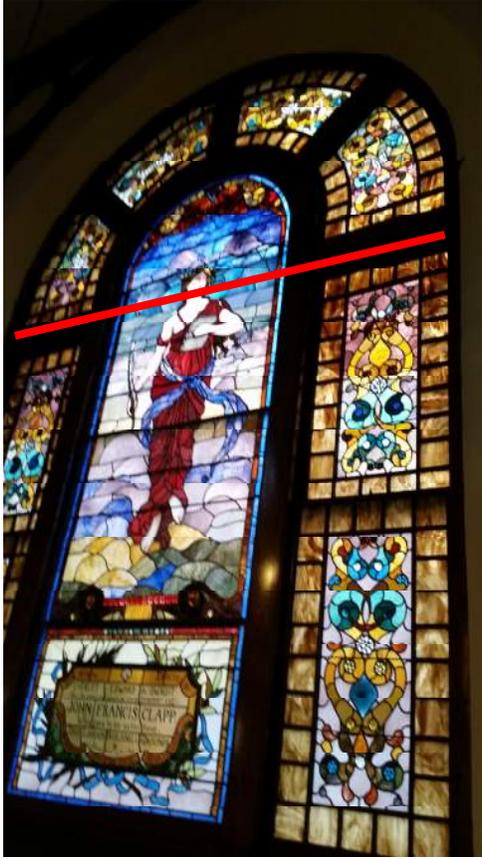
*Photo 9: South Stained Glass Window
Note Missing brace member*

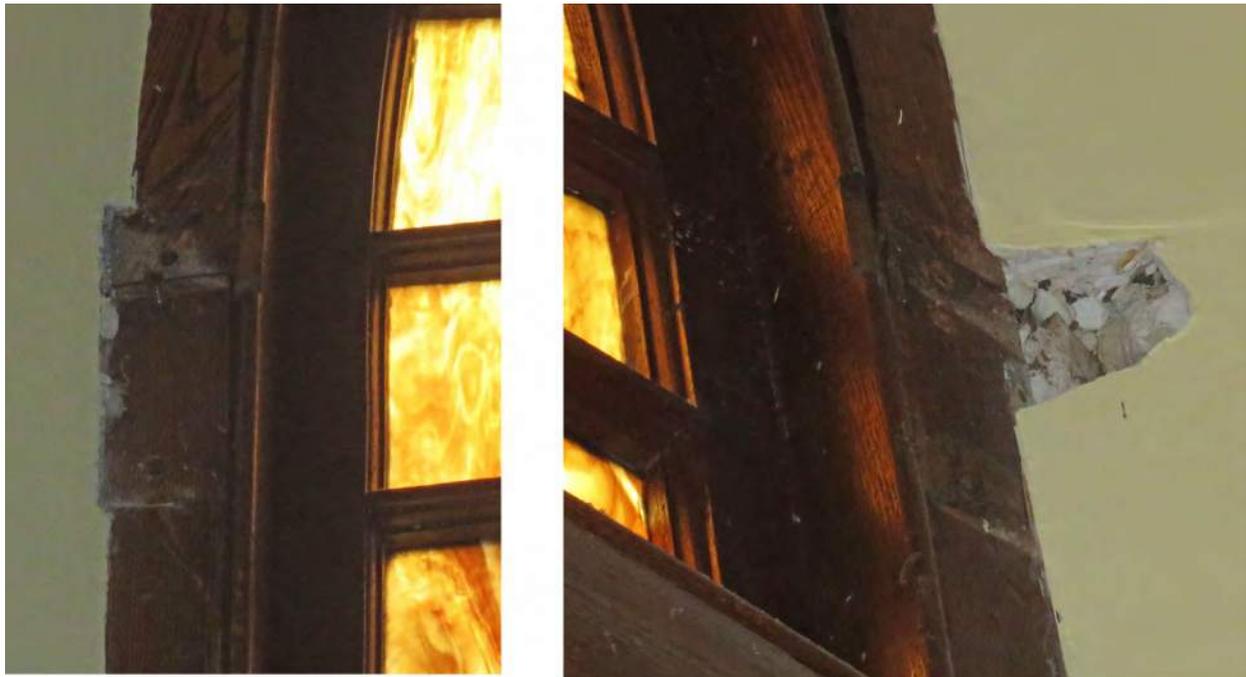
At some point in the past, it appears that there was a wood or steel strut that spanned the window frame just above the springline. It did not line up with the horizontal frame members in the border. Marks from it were left in the wood, and plaster was damaged on the right jamb when it was removed. We recommend that the frame be inspected for structural stability.

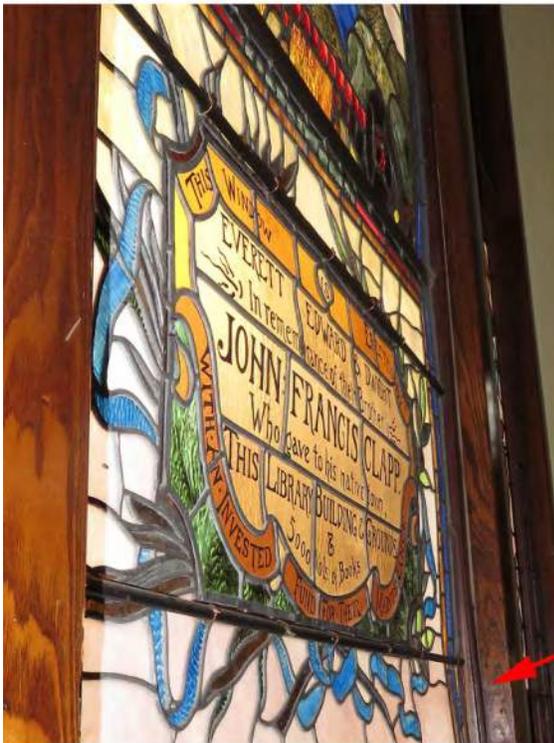
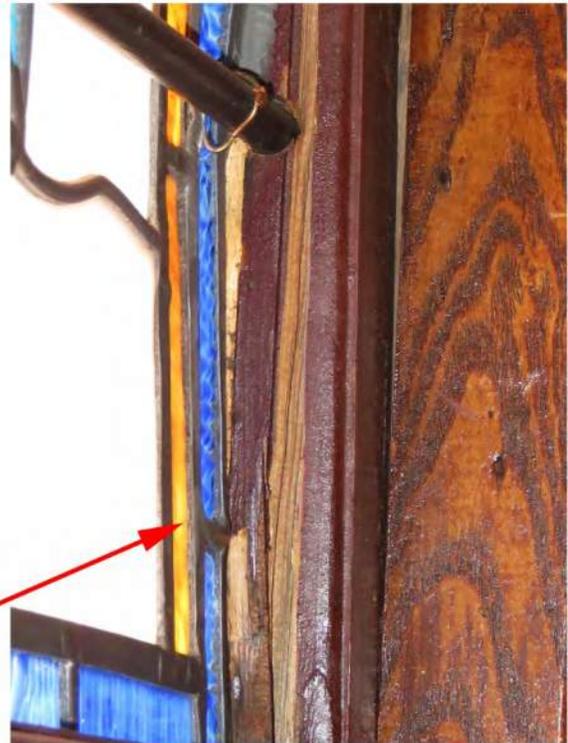
There is bowing in the two bottom sections of the figural lancet where bars are missing. This is one area.

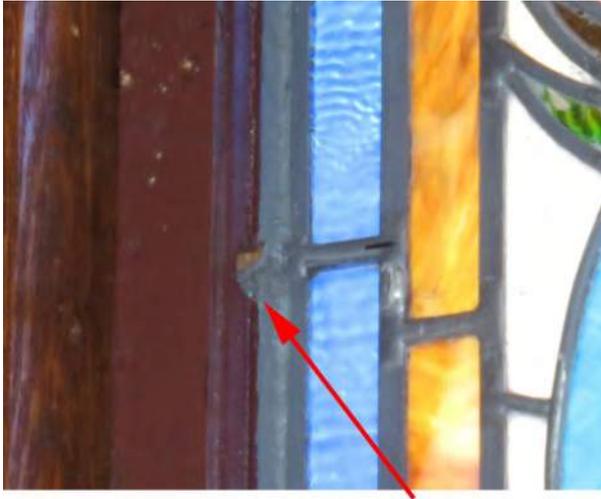
Locations of missing bars are easy to determine because the holes for them still exist in the frame.
