Clapp Memorial Library

Conditions Assessment

A review of existing conditions
and prioritized recommendations for treatment
of the historic Clapp Memorial Library

July 29, 2015

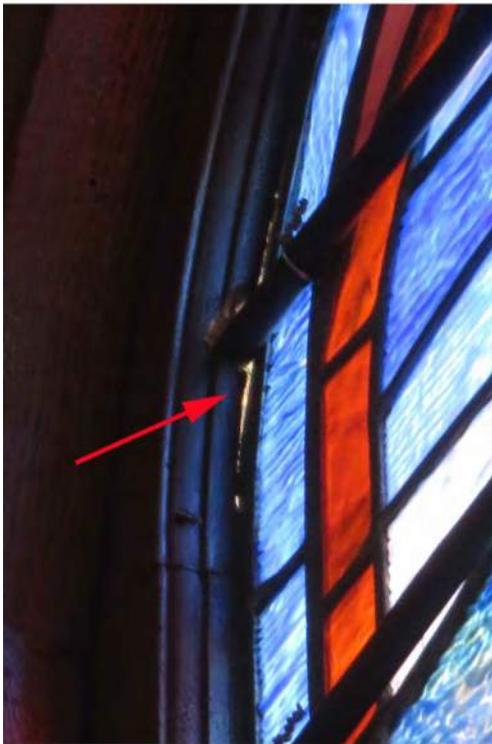
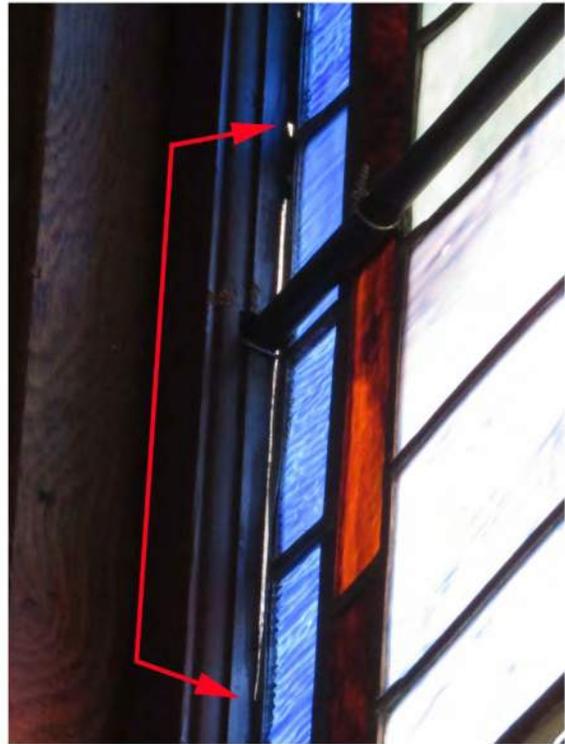
Light leaks (gaps) where the window does not sit tightly in the frame, at the upper left jamb of the center lancet.

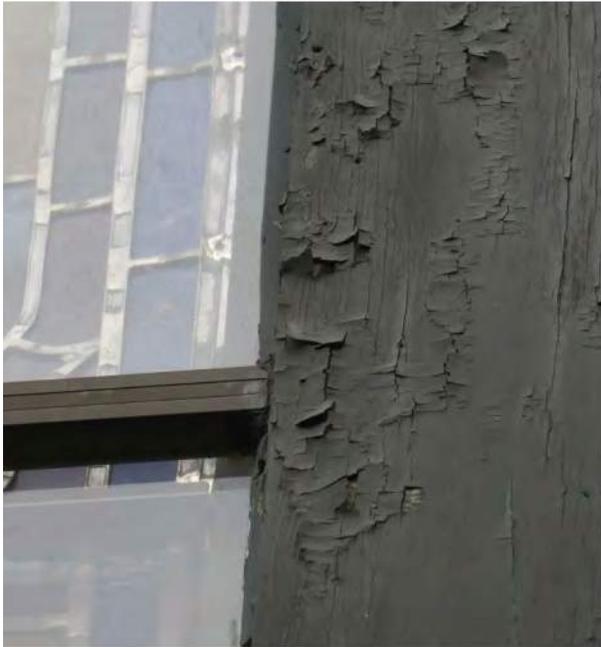
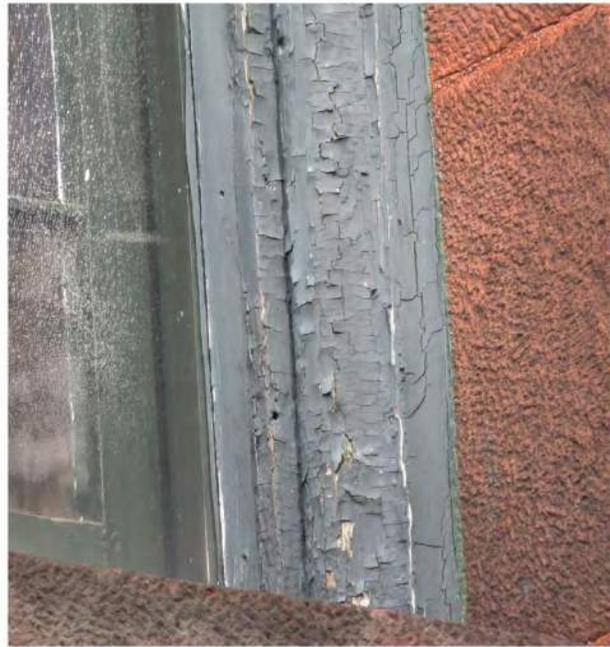
The exterior of the window frame exhibits a great deal of flaking and peeling paint. This should be scraped to bare wood, primed, and repainted.

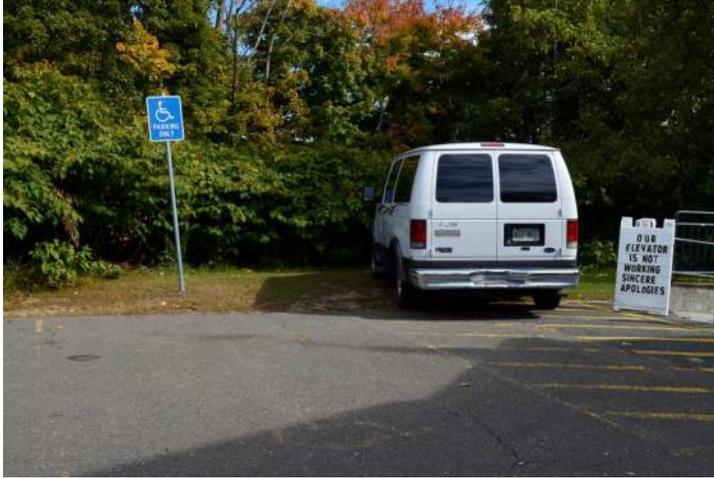
A van accessible parking space has been provided as required by code. The sign should be upgraded to show the latest code language and lines and symbols should be repainted.

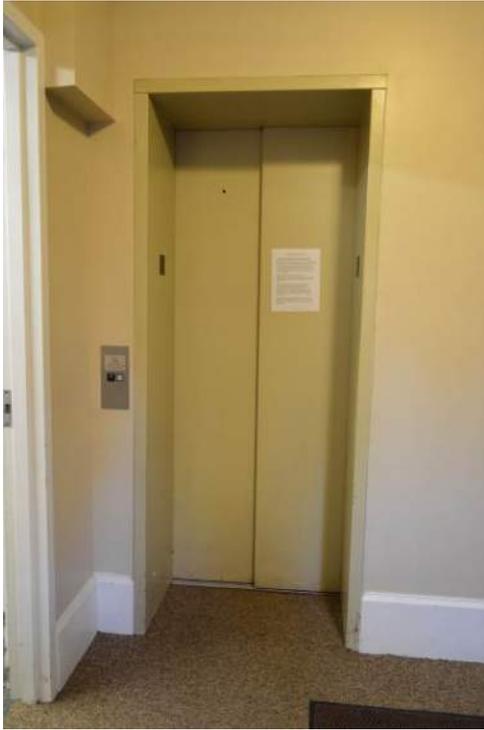
A Limited Use/Limited Access lift provides access to the main library level. Installed in 1999, it is no longer functional and should be replaced.

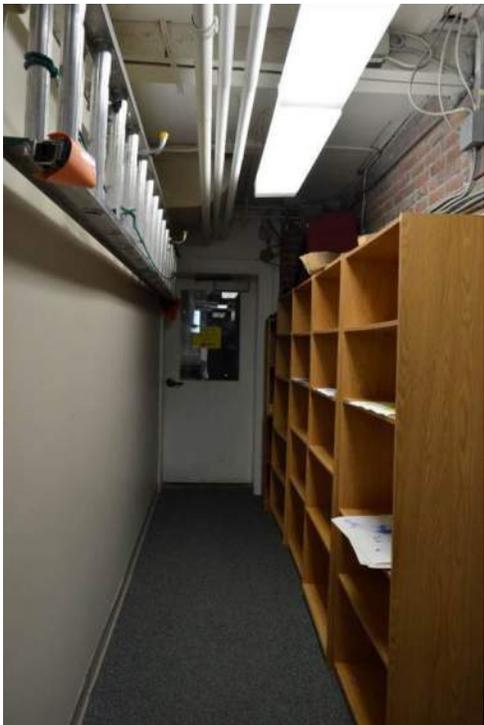
The corridor to a Children's Activity Classroom is the minimum width required for accessibility. There is no space for a wheel chair to turn in the corridor in order to enter the classroom on the right at the end of the array of bookcases. The bookcases should be removed and relocated.

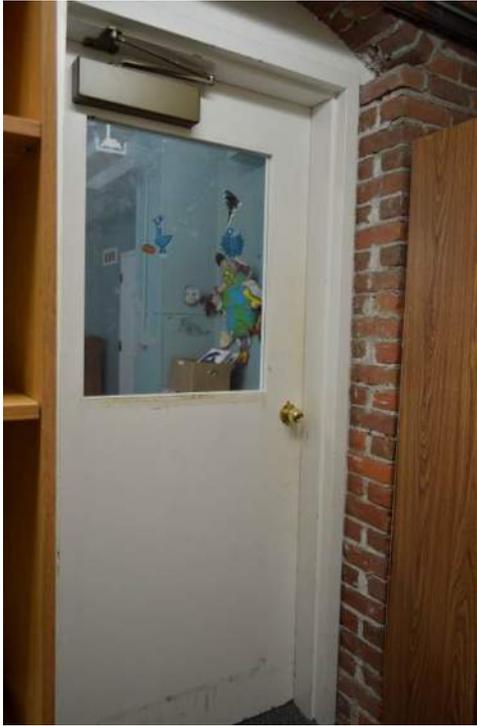
The door to the Children's Activity Classroom is not outfitted with a lever handle classroom lockset as required by Universal Accessibility codes. The door is permitted to swing in rather than out into the egress corridor since the room occupancy is less than 50 persons.

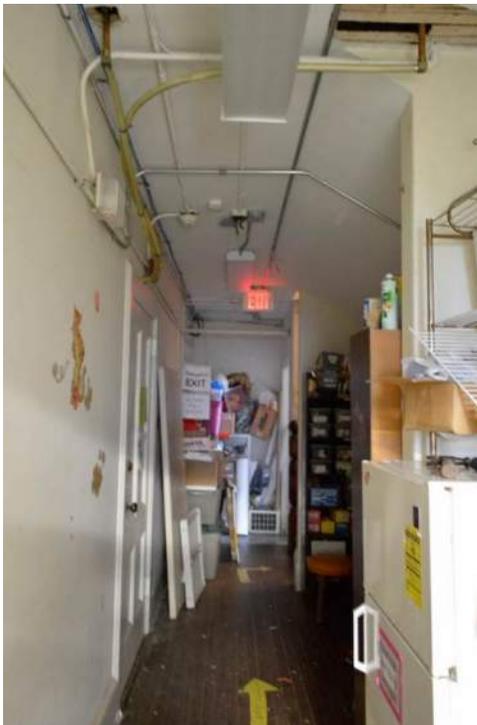
Access to the second means of egress within the lower level is obstructed by stored items within the corridor. The building code requires that egress corridors are kept clear at all times. Storage areas within a dedicated egress corridor are also a hazard. The storage nook on the left side of the photo should be closed off from the egress corridor with a fire rated wall and door system.

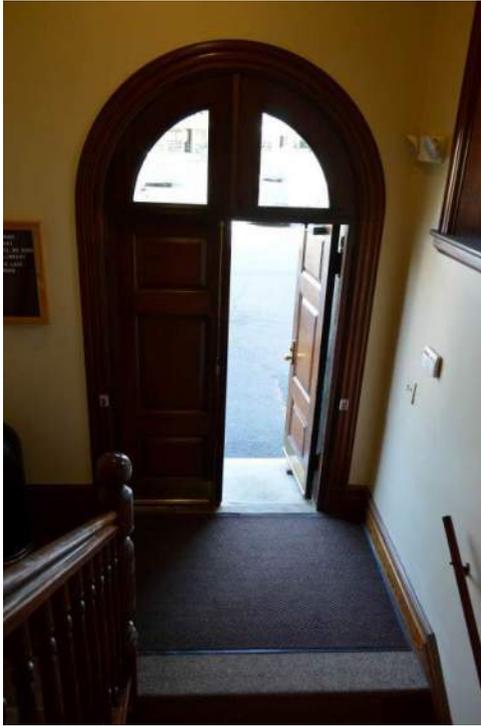
The primary entrance on the north side of the building adjacent to the parking area consists of a pair of 2'-6" double doors with one operable leaf and one fixed leaf. These are the original wood paneled doors which are significant, character defining features of the building. Strictly according to code, each leaf of the doors should be 36" wide. Door hardware is also non-compliant. An egress door should have a panic bar to allow for quick opening in an emergency. There is also the desire on the part of the library to add a vision panel to this pair of doors. The west facing entrance doors could provide a model for this idea.

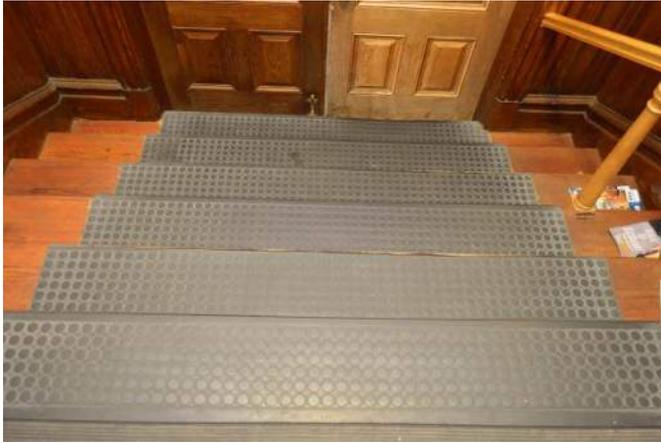
The west vestibule entrance does not comply with current codes as the staircase ends directly in front of the exit doors. Current code requires a landing as deep as the staircase at the base of the stair. A landing in this location is technically infeasible without altering the historic fabric of the building. The past addition of a second handrail closer to the door jamb is an additional safety improvement.

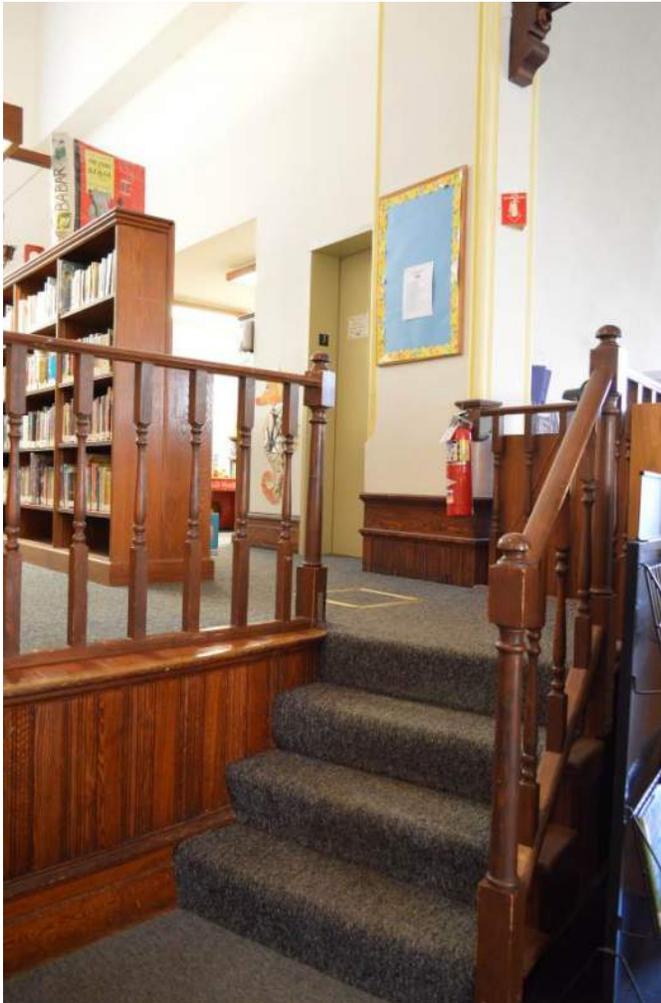
The staircase to the Children's Area has a steeper rise and a narrower tread than allowed by current code. The narrow tread is particularly problematic as the limited dimension does not allow for firm footing for an adult. The staircase could be rebuilt to mimic the current form and direction while altering the rise and run to be more comfortable and code compliant.

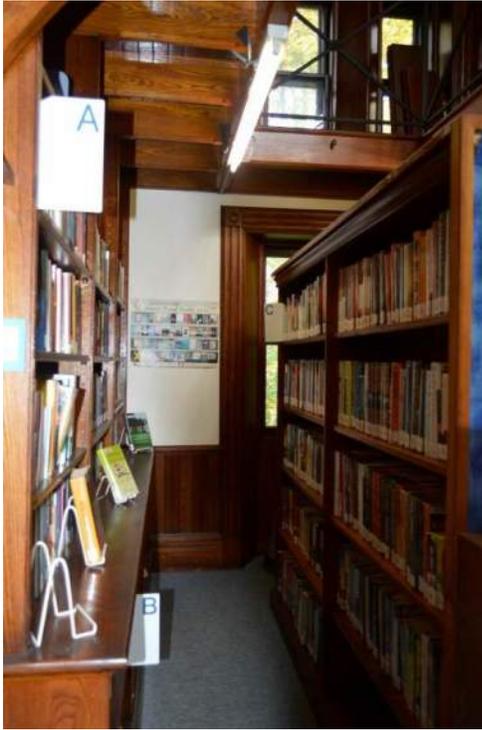
The area between stacks at the main level is 24 inches wide and is not wide enough to accommodate Universal Accessibility at 32 inches minimum. The shelving on the left could be altered to remove the deeper lower shelves. Alternatively, the central shelving units on the right could be altered to provide only one shelf deep. Either option loses necessary stack room and modifies the historic fabric.

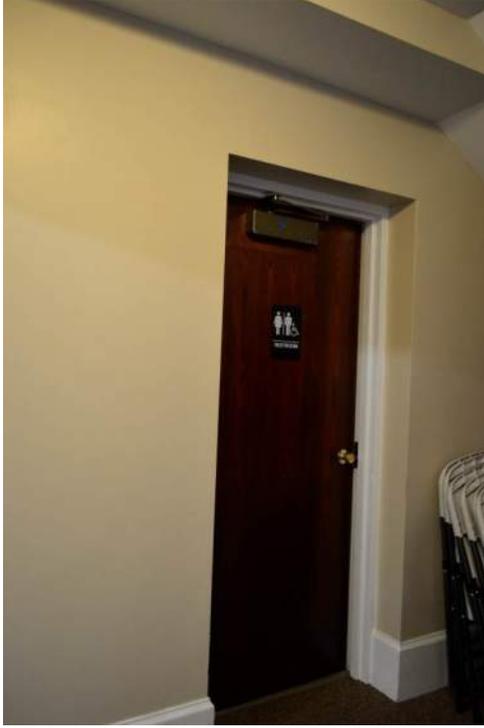
The lower level accessible toilet room meets code for the most part, but the knob handle should be swapped out for a code compliant lever handle.
