Clapp Memorial Library

Conditions Assessment

A review of existing conditions
and prioritized recommendations for treatment
of the historic Clapp Memorial Library

July 29, 2015

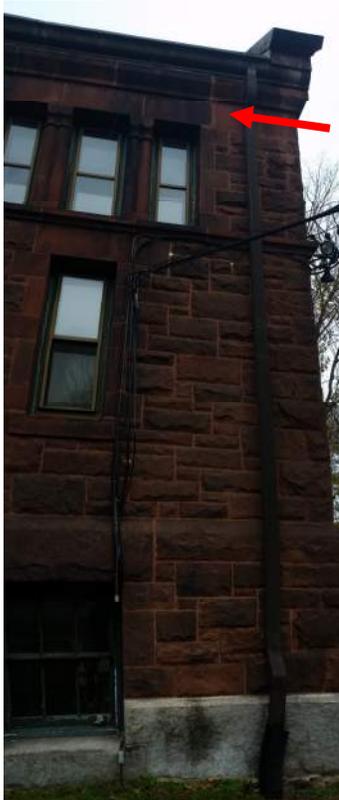
*Photo 2: South West Corner
Note mortar joint that is slightly lighter in color and wider than adjacent joints
(sign of past repairs due to minor wall movement)*

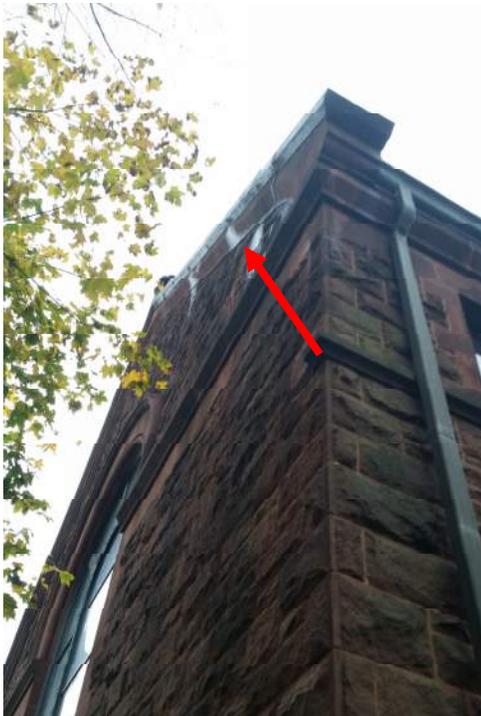
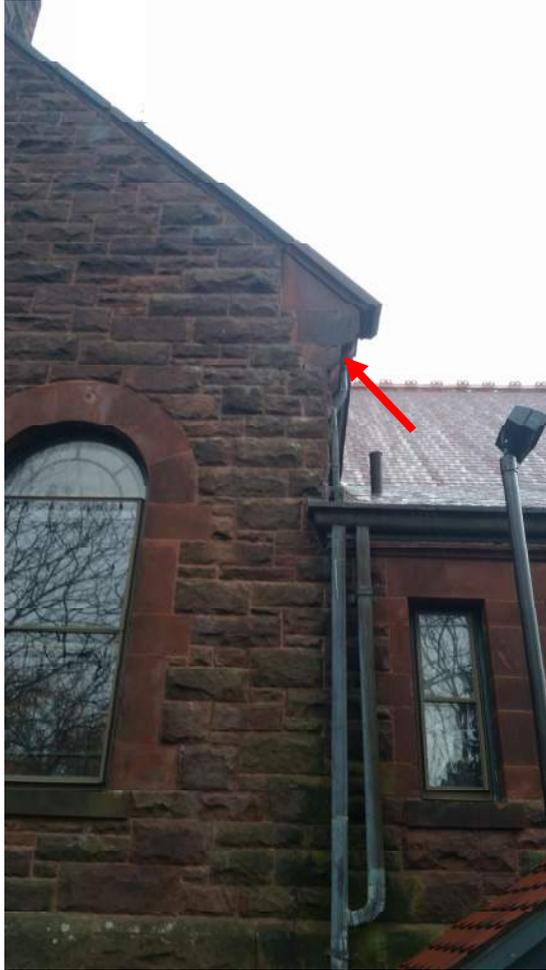
Photo 7: East Façade

Note Past displacement of coping stones

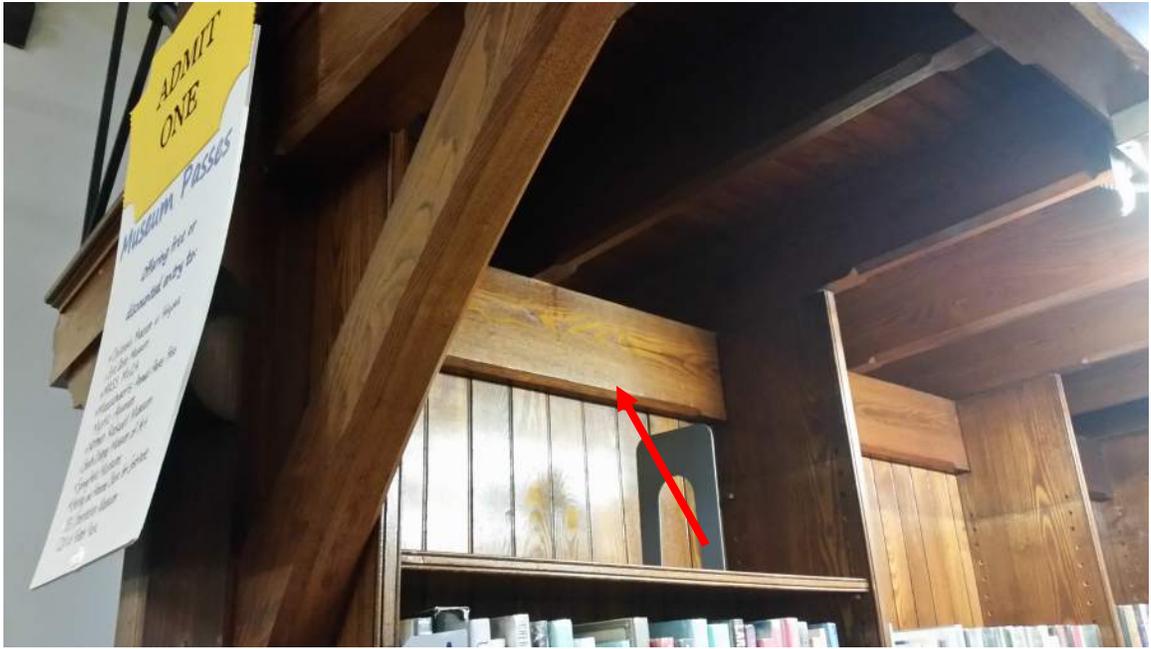
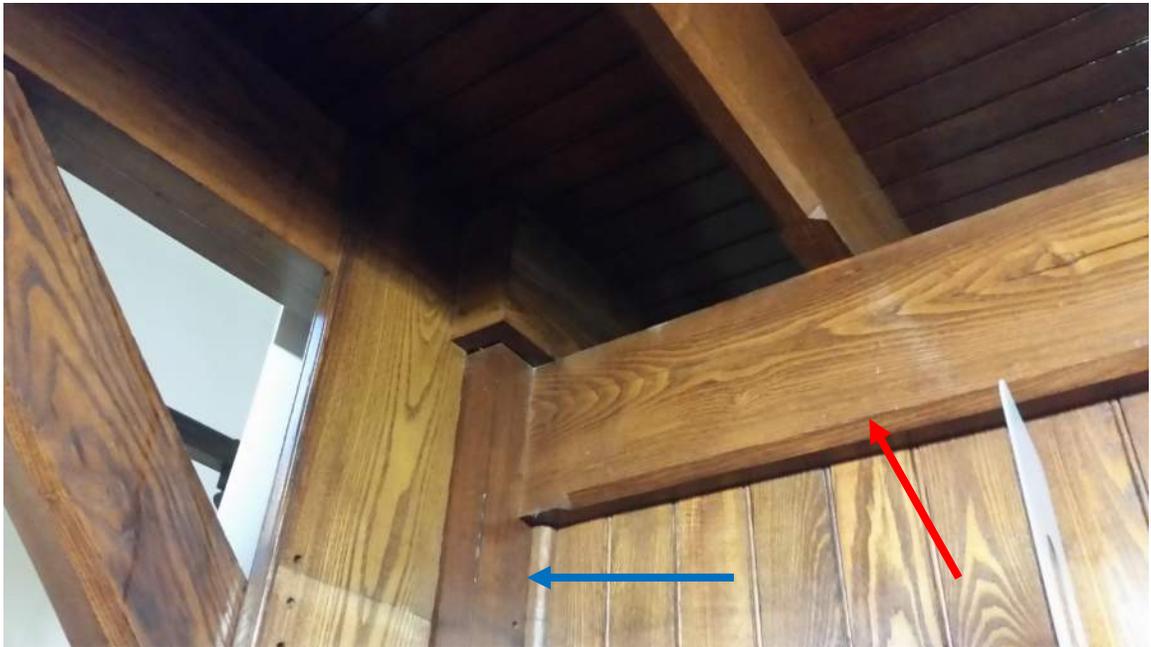
Photos 11&12: Framing Supporting Balcony

*Beam noted by red arrows
Post noted by blue arrow*

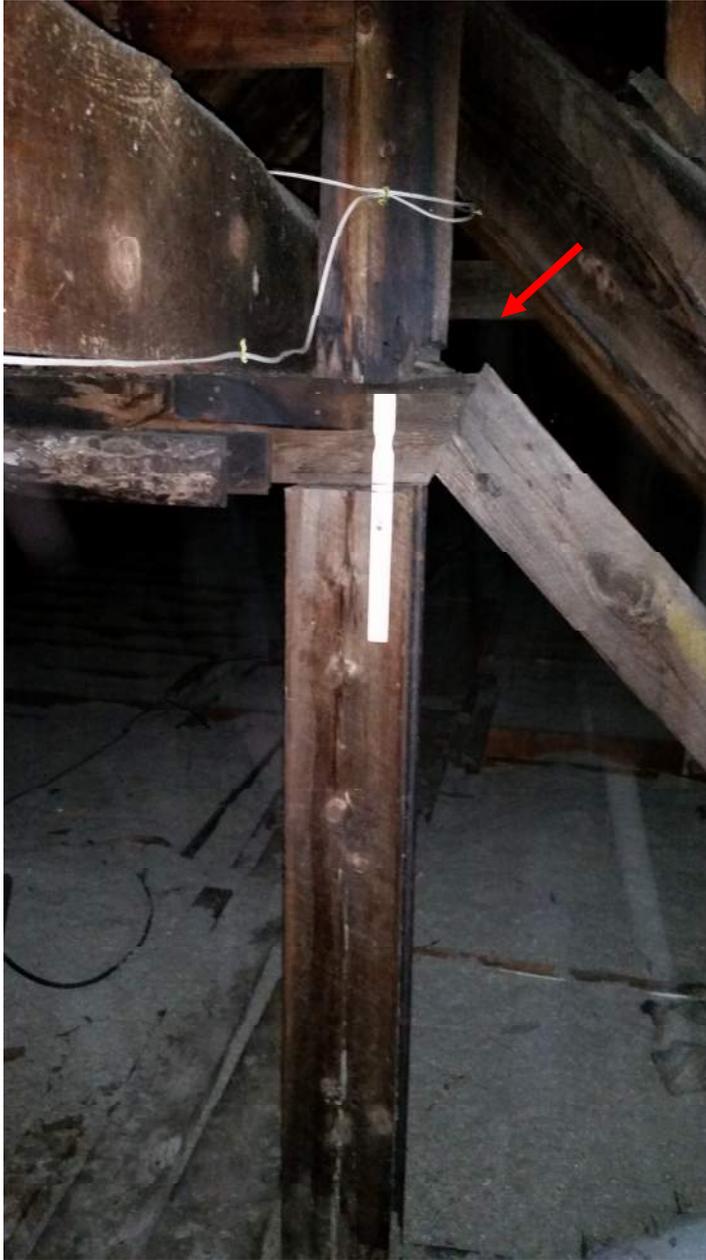
Photo 13: Typical Condition of King Post Trusses Supporting Cupola Post

Note vertical shifting of top horizontal member and gap measuring device

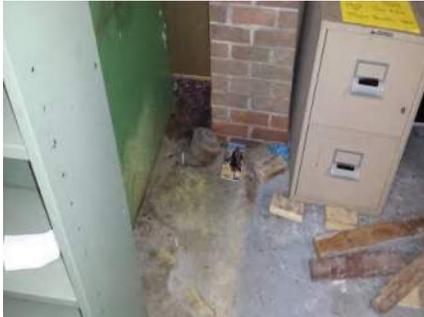
Located within the boiler room slab, the sanitary piping system is routed to the bathroom plumbing fixtures. A floor cleanout was found adjacent to the furnace in the lower level. The majority of the piping appeared to be painted white cast iron in the corridors with some areas being replaced with copper.

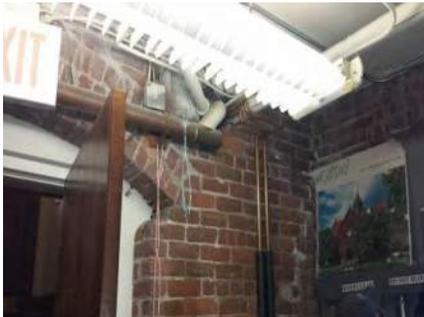
The sanitary system appeared to be in good condition with no signs of leakage or deterioration.

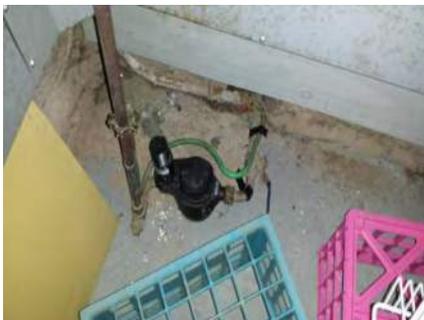
The domestic cold water piping enters the basement and is routed to a water meter. The main pipe has an isolation valve and is routed to the plumbing fixtures located throughout the building. The piping is not insulated and appeared to be in good condition with no signs of deterioration/leakage. The isolation valve appeared to be in fair condition.

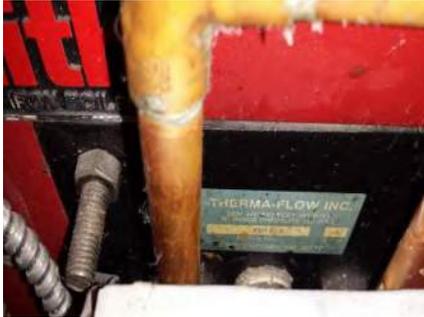
The domestic hot water is provided by an internal coil off the hydronic boiler. Hot water is provided to the bathroom sinks via copper piping routed at the ceilings. All the domestic hot water piping is not insulated and appeared to be in good condition with no deterioration/leaks.

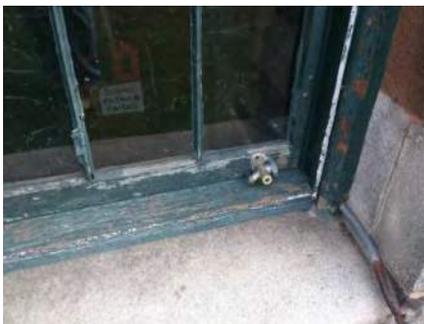
An exterior hose bibb was observed in the front of the library located within a window frame. Piping to the fixture is not insulated and is located in front of the window. The hose bibb and piping appeared to be in good condition.

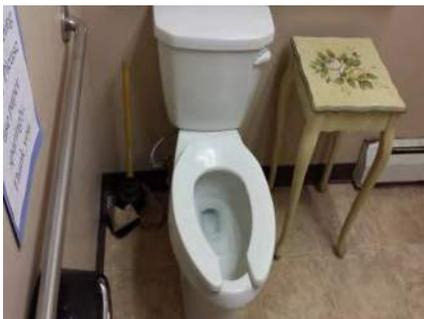
The basement bathroom located adjacent to the ADA ramp has a water closet manufactured by the Gerber Company and provides 1.28 gallons per flush. The domestic cold water piping to the fixture appeared to be recently installed and is in good condition. The water closet and associated accessories appeared to be in good condition.

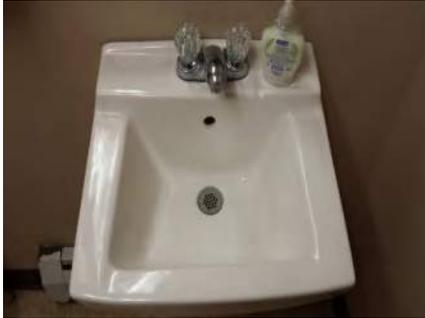
The basement bathroom located adjacent to the ADA ramp has a wall mounted lavatory and faucet. The drain cover/faucet appear to have some deterioration and the basin appeared to be in good condition. The domestic hot/cold piping underneath the fixture is partially insulated and appeared to be in good condition.

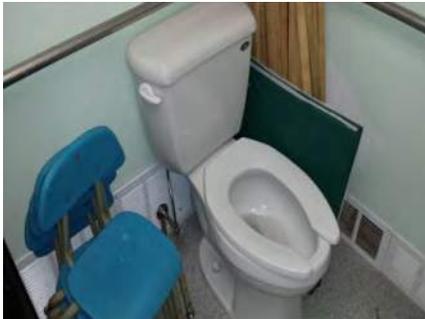
The basement bathroom adjacent to the Children's Activity Room has a water closet manufactured by the Eljer Company and provides 1.6 gallons per flush. The domestic cold water piping, water closet and associated accessories appeared to be in good condition.

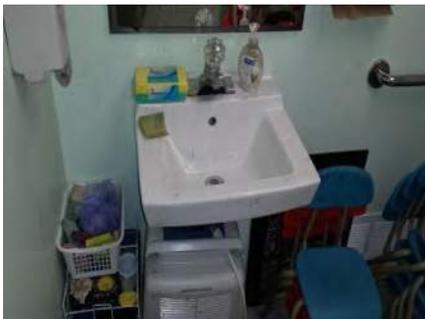
The basement bathroom adjacent to the Children's Activity Room has a wall mounted lavatory and faucet. The drain cover/faucet appear to have some deterioration and the basin appeared to be in fair condition. Paint was found on the front and sides of the lavatory. Piping underneath the fixture appeared to be in good condition.

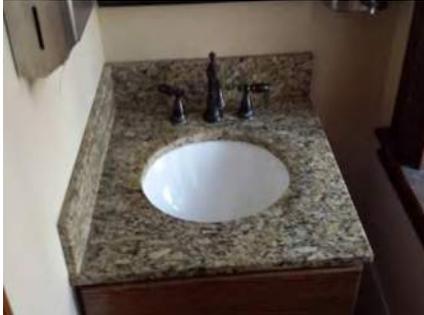
The main level side entrance area has a small bathroom equipped with a floor mounted lavatory and faucet. The fixture appears to have been recently installed and in good condition.

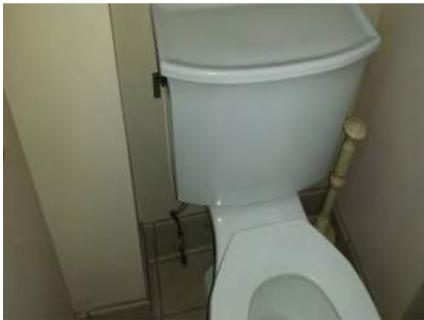
The small main level bathroom has a water closet manufactured by the Kohler Company and provides 1.25 gallons per flush. The fixture, piping and associated accessories appear to be recently installed and in good condition.

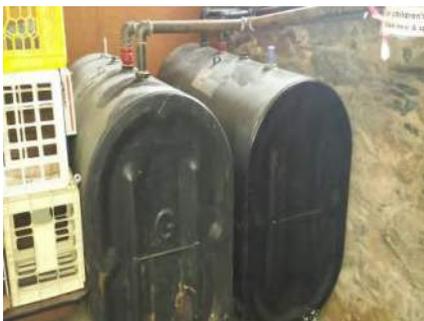
Two (2) above ground #2 fuel oil tanks were observed in the boiler room. Each tank has a capacity of two hundred and seventy five (275) gallons and are manufactured by the Granby Company. The fuel oil tanks appear to be in good condition with minor deterioration present on the enclosures.

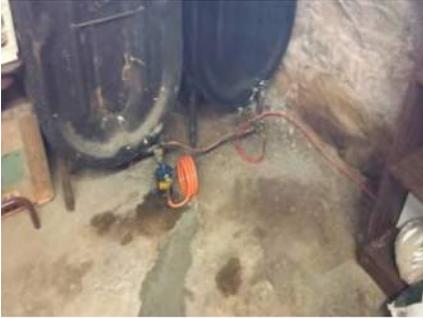
The fuel oil supply lines to and from the boiler and forced hot air furnace are routed in a trench that was recently installed. The lines and filters appear to be newer and in good condition.

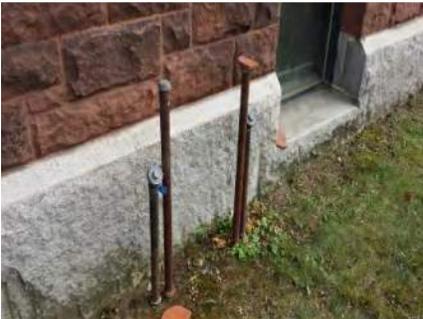
Each fuel oil tank has a separate fill and vent pipe located at the front of the library's exterior. The piping appeared to be in good condition with one of the caps missing (covered by a piece of clay).

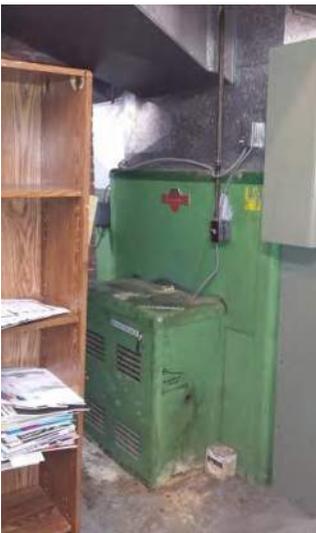
An oil-fired furnace is located in the boiler room and is manufactured by the Waterbury Company. The unit appears to be from the 1950's and has a side filter box with two (2) 16x25 pleated filters. The unit did not have any information regarding capacity and appeared to be in fair condition.

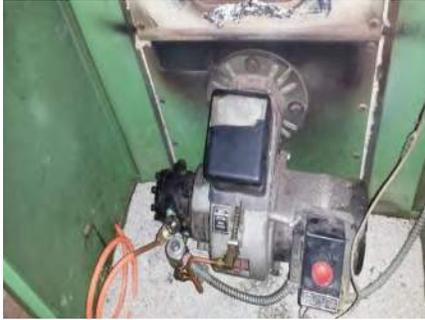
The furnace has an oil fired burner manufactured by the Carlin Company model CRD. The burner provides a firing range of 2.00-5.00 gallons per hour, appeared to be over twenty (20) years old and is in fair condition.

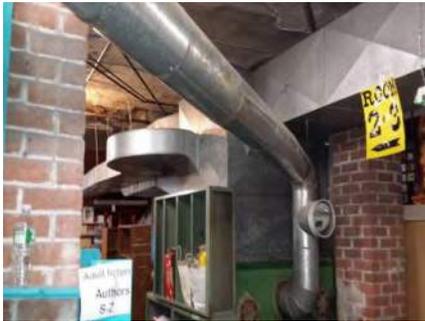
Breeching for the furnace is routed to the chimney stack located in the rear of the library. A barometric damper located on the breeching provides the required draft. The breeching appeared to be in good condition with deterioration at the connection flange.

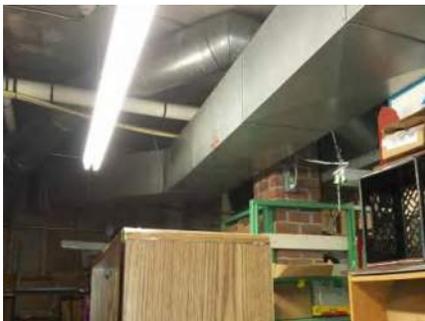
Ductwork distribution located within the boiler room is a mix of round and rectangular. Two large ducts feed the main level with one large round return. Several smaller ducts serve storage rooms and miscellaneous areas. All the ductwork is visible as it is not insulated and appears to be in good condition.

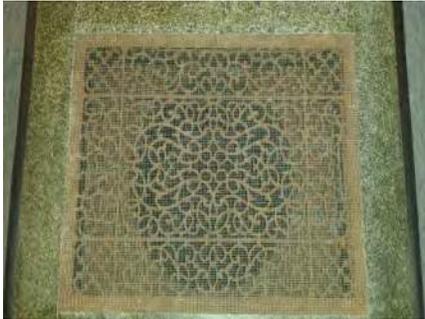
The main level has two (2) floor mounted supply grilles that are served by the furnace. Each grille has different dimensions; 40"x29" and 40"x44". The grilles appear to be in good condition with no deterioration present.

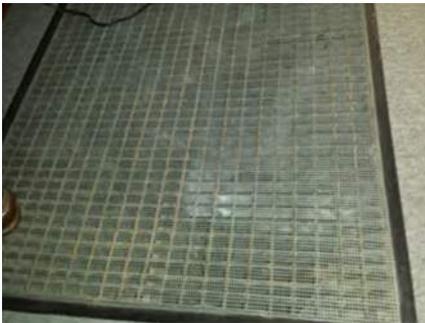
A large floor return grille is located on the main level in the stack area. The grille is connected via ductwork to the oil-fired furnace. The grill measures 60"x 40" and appears to be in fair condition with no deterioration present.

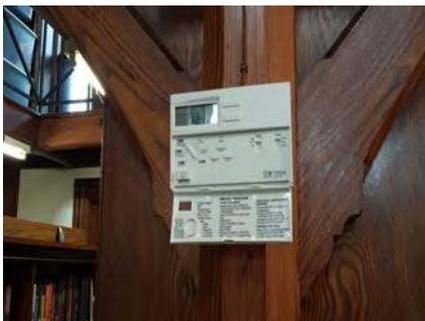
A wall mounted programmable thermostat manufactured by the Lux Company controls the oil-fired furnace. The unit is located on the main level near a supply grille and appears to be in good condition.

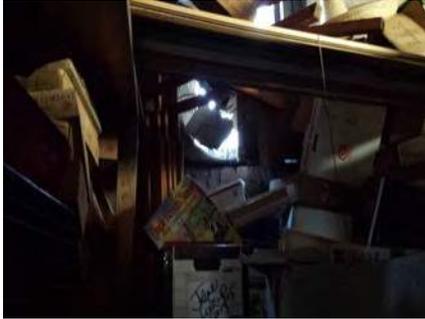
A wall mounted exhaust fan was found in the storage area of the boiler room. The area was not accessible due to the items in storage.

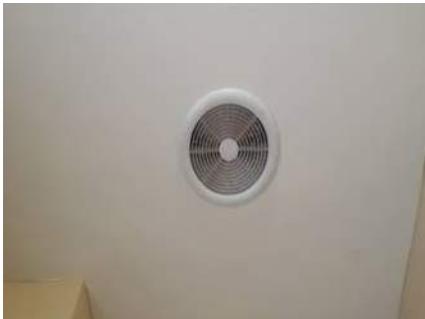
The main level bathroom has a ceiling mounted exhaust fan controlled by the local light switch. The fan appeared to be recently installed and in good condition.

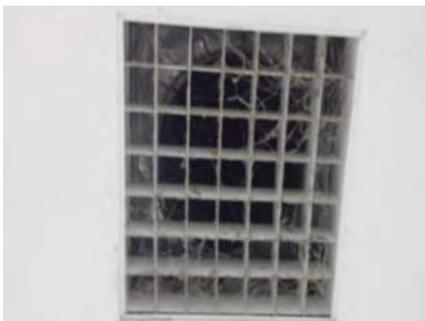
The basement bathrooms have above ceiling exhaust fans and 8"x8" grilles in the ceiling grid. The fans are controlled by a local light switch and appeared to be in good condition. Debris was found in the ceiling grilles and related ductwork.

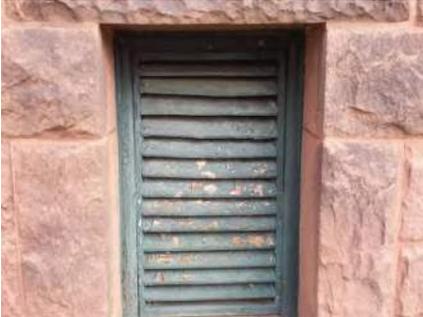
Located at the front of the library a 23"x28" louver is used for bathroom exhaust. The louver has major deterioration and debris is located between the damper blades. The overall condition of the louver is poor.

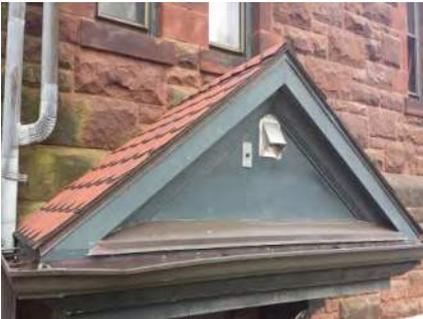
Above the ADA ramp, a hooded wall cap for a bathroom exhaust fan is found. The cap appeared to be in good condition with no deterioration or debris found.

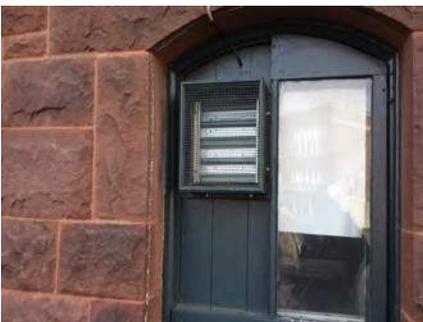
The elevator machine room has a thermostatically controlled louver/damper. The components of this system appeared to be recently installed and in good condition.

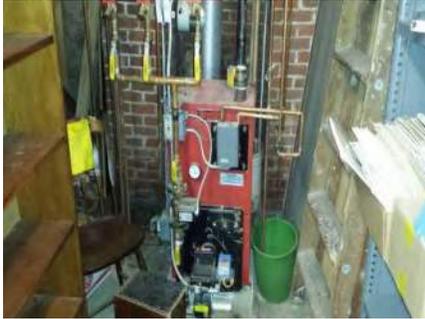
A hot water oil-fired boiler manufactured by the Smith Company is located in the boiler room. The boiler provides hot water to the three zones that consist of baseboard radiation and a fan coil unit. The boiler has an output rating of 98 MBH and also provides domestic hot water via an integral coil. Installed in 2003 the boiler appears to be in fair condition with deterioration present throughout.

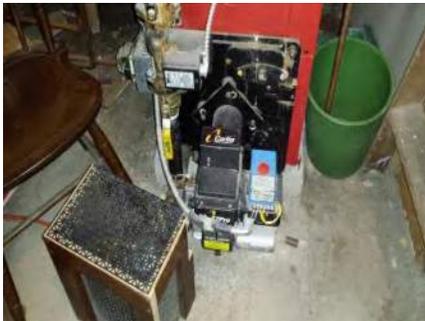
The oil-fired burner for the boiler is manufactured by the Carlin Company model EZ-1HP and is rated for .50 -1.65 gallons per hour. Overall the burner components appeared to be in good condition.

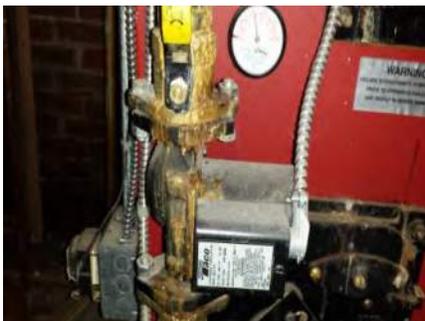
The hot water is distributed via an inline circulator pump manufactured by the Taco Company model 007-F5. The pump appeared to be in poor condition with major deterioration observed at the flanges.

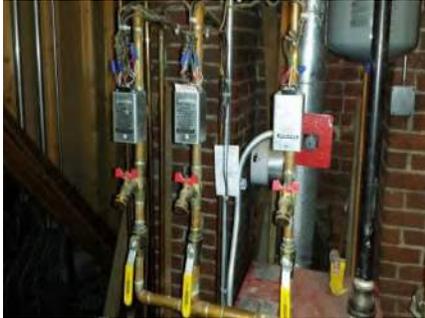
Three zone valves are located above the boiler and are interconnected to the thermostats serving the zones. The wiring appeared to be loose and excessive but not an area of concern.

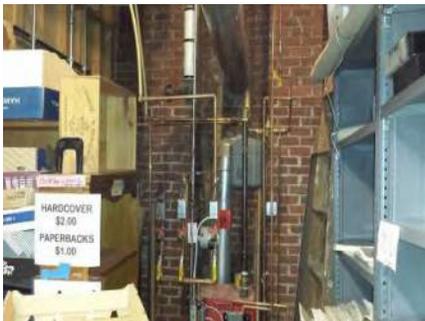
Piping for the hot water system mainly consists of copper with PEX piping for one (1) zone. No piping insulation was found throughout the building. The hydronic accessories included an expansion tank, breeching, pressure reducing valve and air vent. All the piping and accessories appeared to be in good condition.

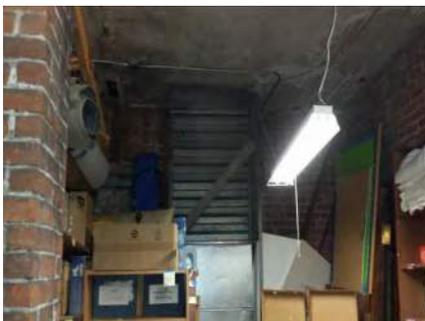
Combustion air for the furnace and boiler is provided by an exterior louver and motorized damper located within the boiler room. The motorize damper is interlocked to the burners and appeared to be in good condition.

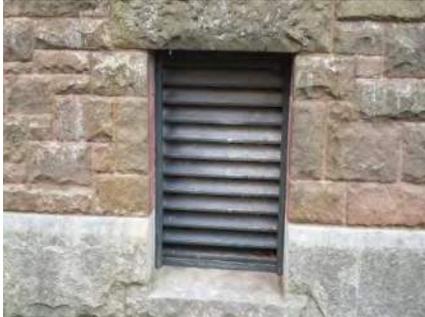
Exterior louver for the combustion air's motorized damper is located at the rear of the library. The louver dimensions measured 38"x 49" with a 2" frame and fixed blades. Some minor deterioration was found on the damper blades, overall the louver was in fair condition.

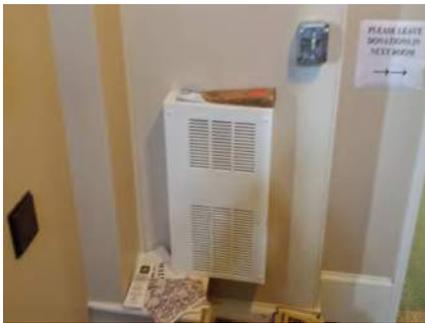
A fan forced fan coil unit is located near the ADA entrance. The unit is manufactured by the Turbonics Company, model 11/13 WM, and is supplied by hot water from the boiler. The unit is operational and appeared to be in good condition.

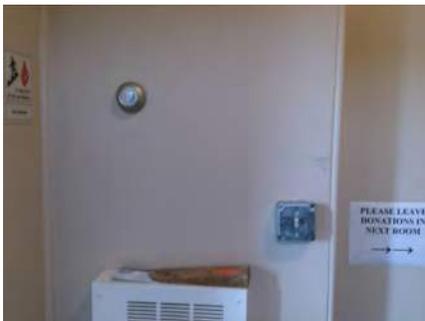
A wall mounted thermostat manufactured by the Honeywell Company model T87 controls the fan coil unit via relay in boiler room. The thermostat appeared to be over twenty (20) years old and in fair condition.

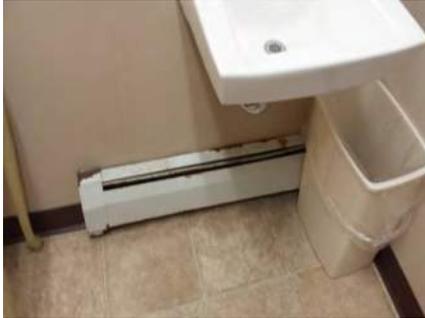
The basement bathroom adjacent to the ADA entrance has 39" of hydronic baseboard radiation. Debris and deterioration was present on the enclosure and it appeared to be in poor condition.

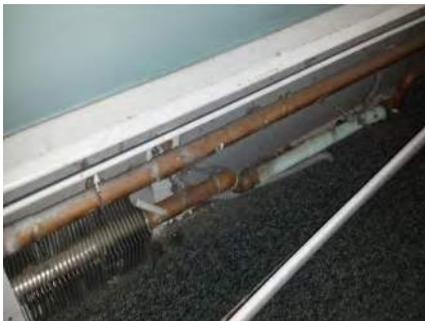
Baseboard radiation is also present in the elevator machine room, Children's Activity Room and corridor. The fin tube appeared to be in good condition while the enclosure appeared to be in fair condition with debris and deterioration

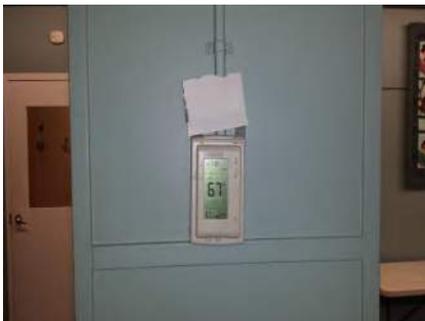
A wall mounted thermostat manufactured by the Ritetemp Company controls the valve and associated relay in the boiler room. A second thermostat of the same type can be found in the main level office area. The thermostats appeared to be over ten (10) years old and in good condition.

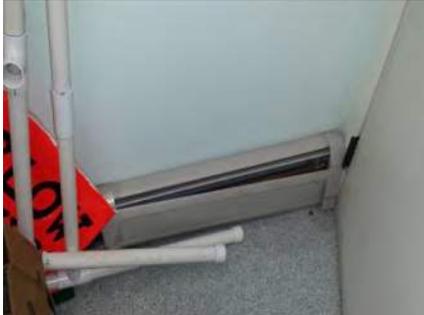
The bathroom located next to the Children's Activity Room has baseboard radiation located behind the door. The enclosure appears to have damage and debris. The unit appears to be in poor condition.

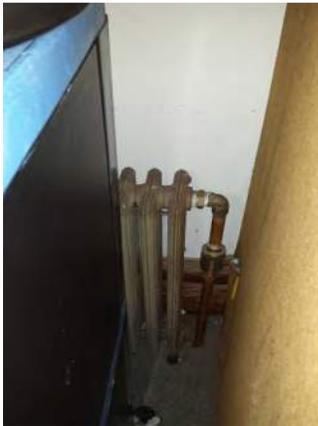
The main level office area has a free standing cast iron radiator located behind storage cabinets. An isolation valve and air vent are located on the supply piping to the unit. The radiator appeared to be in fair condition.

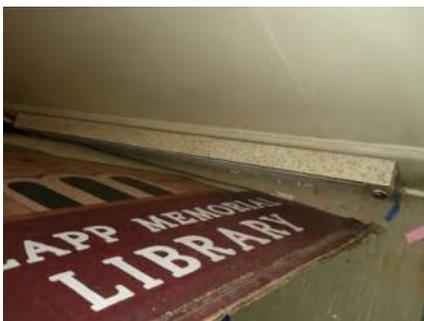
A basement storage room has a 48" electric baseboard radiation unit. The enclosure has major deterioration and the unit appeared to be in poor condition.

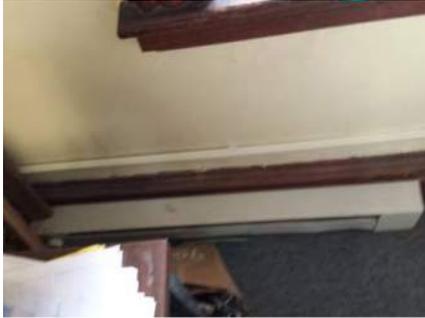
Electric baseboard radiation was found a main level office. The unit appeared to be in fair condition with no deterioration present.

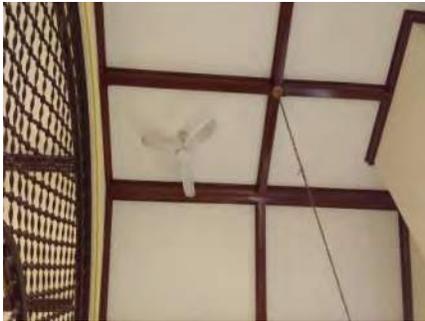
Several paddle type ceiling fans are located at the main level ceiling. The fans appeared to have debris on the paddles and in fair condition.

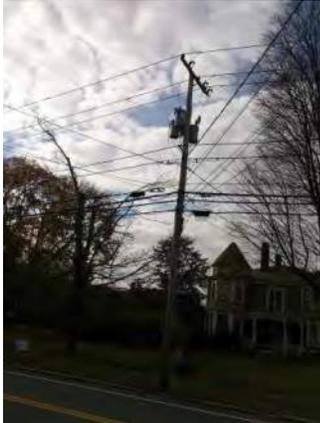
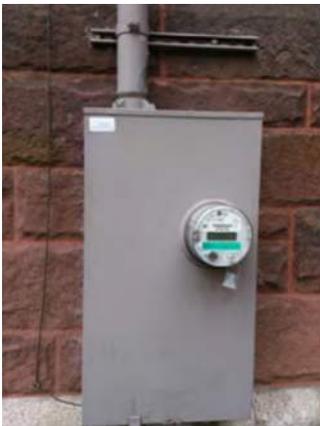
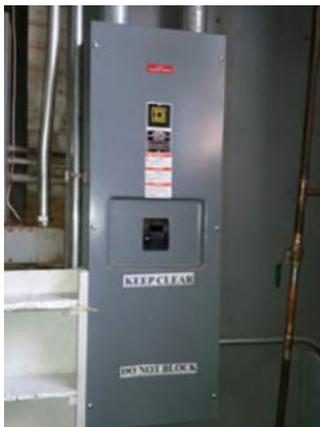
The electrical service for the building is provided via an overhead aerial service drop from a utility pole located on the opposite side of South Main Street. The service drop is routed to a second utility pole located in the southwest corner of the property and then continues to the weather head and Class 320 meter socket located on the southwest corner of the building.

Service wiring and conduit then enters into the basement of the building via an interior trough and terminates at a 400 A service entrance (SE) rated circuit breaker disconnect switch manufactured by Square D.

Voltage configuration to the building is 120/208V, 3 phase, 4-wire with an amperage (A) rating of 400A.

The electrical service for the building has been upgraded within the past three years and is in very good condition.

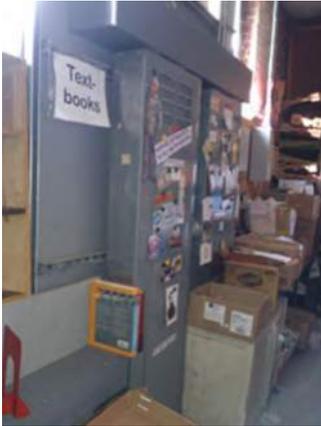
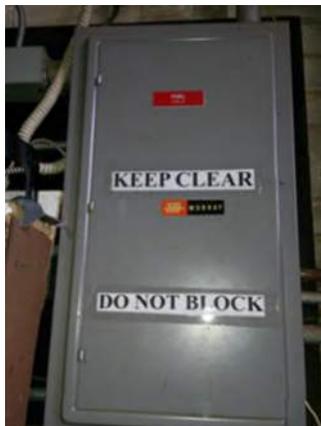
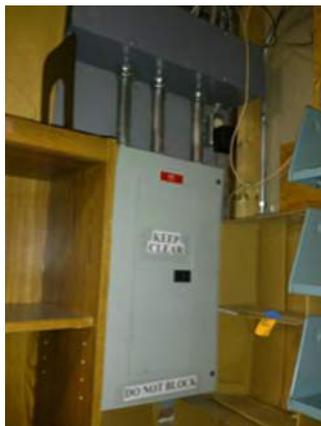
Electrical distribution within the building is provided by five (5) electrical panels located in the basement. The main distribution panel (MDP) is a 400A, 120/208V, 3 phase, 4 wire, main lug only (MLO) panelboard located on the west wall of the basement a few feet away from the 400A SE disconnect switch, Wiring is routed from the 400A SE disconnect to panel MDP via a 6" x 6" wireway. Panel MDP provides power to the other four (4) electrical panels within the basement.

Adjacent to panelboard MDP is panelboard PB-1. This is a 225A, 120/208V, 3 phase, 4 wire, MLO panel. This panel provides power to the elevator and receptacles within the building as well as to the handicapped door operator and exhaust fans.

Panel LC-1 is located adjacent to the 400A SE disconnect switch. This panel is a 100A, 120/208V, 1 phase, 3-wire MLO load center type panel. The panel directory was missing for this panel but it would seem that this panel provides power to receptacles, lighting and mechanical equipment.

Panel LC-2 is located adjacent to the basement emergency exit doorway. This panel is also a 100A, 120/208V, 1 phase, 3-wire MLO load center type panel. This panel provides power for receptacles, lighting, bathroom heat and hot water furnace.

Panel LC-3 is located in the basement corridor. This panel is a 100A, 120/208V, 3 phase, 4 wire MLO load center type panel and is dedicated to serving the snow melt system for the handicap entry into the building. This panel's cover has had a keyed lock installed to prevent unauthorized personnel from opening it as it is located in a public area.

All the panels seem to have been replaced when the electrical service was upgraded and are in very good condition.

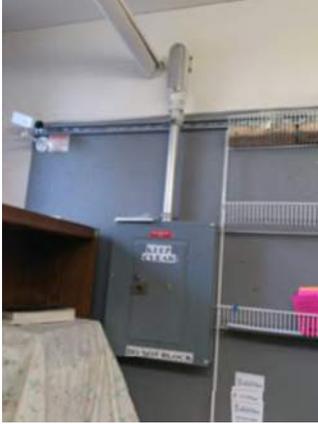
placed in front of the other panels in spite of warning labels advising to keep the area clear. The panels no longer have the minimum three (3) foot clearance required by current code. All items within the three (3) foot area in front of the respective panels should be relocated to allow unobstructed access required by current code.

A surge protection device should be installed for panel MDP at a minimum to reduce potential damage to building equipment, computer systems and lighting during utility company power surges and/or lightning.

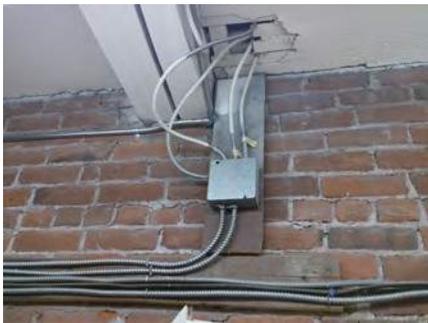
Branch circuit wiring and conduit was primarily observed to be building wiring routed in rigid metal conduit or flexible metal conduit. Surface raceway (Wiremold) was also observed. In addition, a small amount of non-metallic sheathed cable (Romex) was observed.

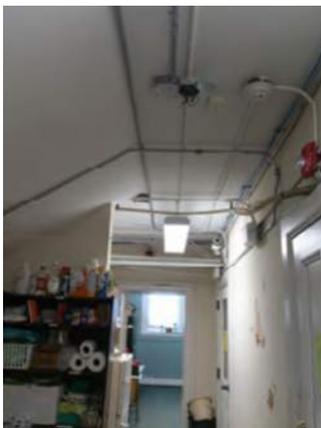
A ceiling mounted junction box in the basement hallway had the cover unscrewed thereby exposing the live wiring. Cover should be installed correctly.

A few junction and outlet boxes have missing knockouts. Knockout caps should be installed for junction and outlet boxes missing them.

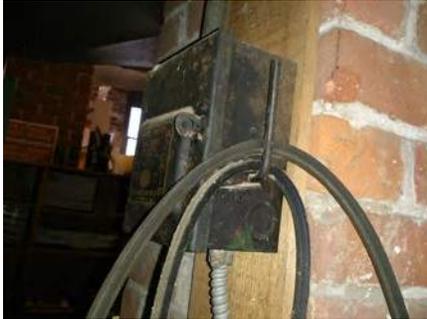
The fused disconnect for the building's hot air furnace is antiquated. Although it is in fair condition for its age, the disconnect should be removed and replaced as part of any upgrade to the hot air furnace.

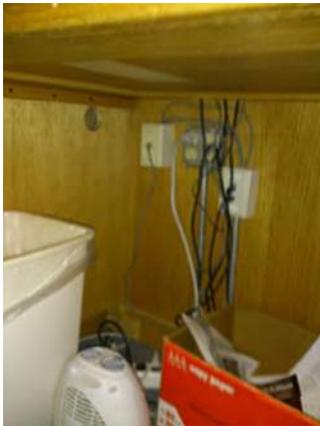
Wiring devices consisted of receptacles, switches and occupancy sensors. Duplex receptacles were located throughout the building. However, a number of power strips appeared to be in use. GFCI duplex receptacles were located in the restrooms with the exception of the restroom located on the main floor. No receptacle was located within this restroom. One (1) GFCI duplex receptacle was located on the exterior of the building near the handicapped entry. This receptacle is controlled by a switch located in the basement corridor.

Additional occupancy sensors should be located in the other restrooms and offices within the building. A GFCI receptacle should be installed in the restroom located on the main level. Additional receptacles should be installed to eliminate or at least minimize the use of power strips.

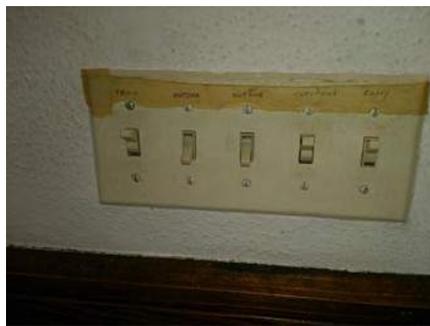
Control of the lighting was provided by single and three way lighting switches. A wall occupancy sensor switch was located within the restroom adjacent to the Children's Activity Room. However, this occupancy sensor did not appear to be functioning properly.

Only one switch was located in the Children's Activity Room. However, the room contains two (2) entry doors.

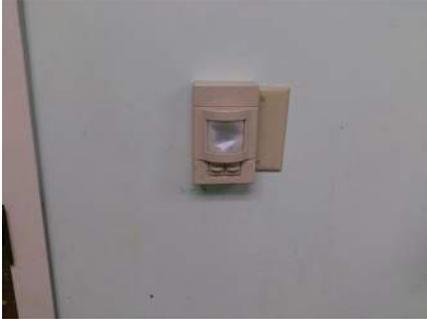
The majority of the existing receptacles and switches observed appeared to be in place a number of years and in fair condition. An additional switch should be added at the second doorway of the Children's Activity Room. The existing occupancy sensor within the restroom adjacent to the Children's Activity Room should be removed and replaced.

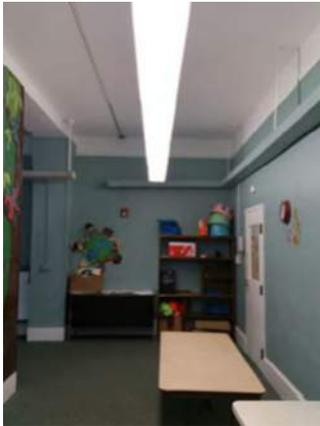
A mixture of light fixtures was observed within the building. On the basement level, lighting consisted of ceiling mounted incandescent light fixture in the handicapped entry lobby, recessed 2'x4' fluorescent light fixture with T8 lamps in the restrooms, pendant mounted 1'x4' in the Children's Activity Room and hallways. A 1'x8' fluorescent fixture was also observed in the hallway as well. These light fixtures were controlled by single pole and three way switches.

The condition and age of the light fixtures in the basement varied. The slim width 8 foot fluorescent fixtures were in good condition and should remain and be reused. Pendant mounted pull chain type 1'x4' fixtures should be removed and replaced with the circuiting rewired so that the fixtures are controlled by light switches. Plugin type suspended fixtures shall also be removed and replaced with hardwired fixtures controlled by light switches. The recessed 2'x4' light fixture on the handicapped entry lobby restroom in the basement was missing its lens. A new lens should be installed.

Children's Activity Room and hallway lighting should be removed and replaced with more energy efficient fixtures.

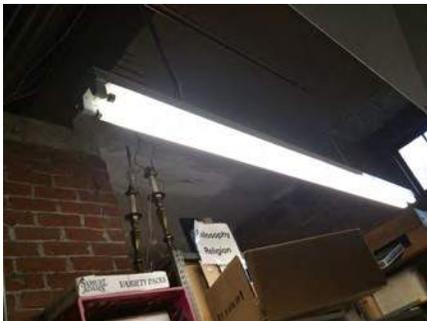
Lighting within the boiler room consisted of pendant mounted slim width 8 foot fluorescent fixtures controlled by light switches. Also observed were pendant mounted 1'x4' fluorescent fixtures controlled by pull chains, chain suspended 1'x4 fluorescent fixtures with plugin cords and ceiling mounted porcelain sockets with pull chains.

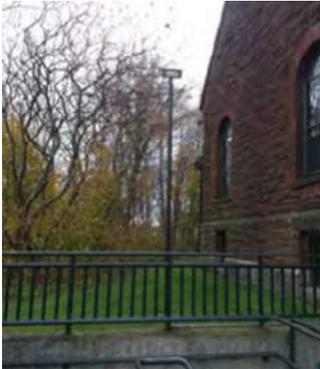
A site pole flood light illuminates the handicapped entry ramp. This fixture appears to be controlled by a building mounted photocell sensor. A recessed light fixture was also observed in the handicapped entry overhang canopy.

With exception of the pole mounted flood light which is in good condition, the exterior lighting is in fair to poor condition and should be removed and replaced with energy efficient fixtures.

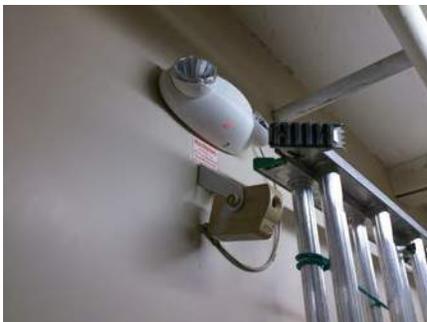
It appears that emergency lighting within the building is provided by dual head emergency lighting units with battery backup. The emergency lighting units appeared to be in good condition and functional with exception of the combination emergency lighting/exit sign unit in the boiler room. One lamp on this unit was non-functional. The lamps of the unit in the basement corridor are not orientated correctly and the location of the ladder is blocking proper illumination of the area. The installation of additional units would be required to meet current code requirements.

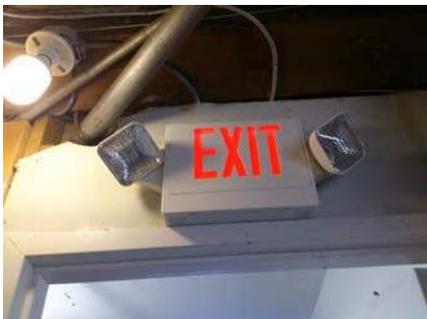
Egress lighting consisted of exit signs with battery backup. The existing exit signs were functional and in good condition. However, the exit sign the Children's Activity room in the basement appeared to be AC only. No remote battery pack units were observed. The exit signs seemed to be

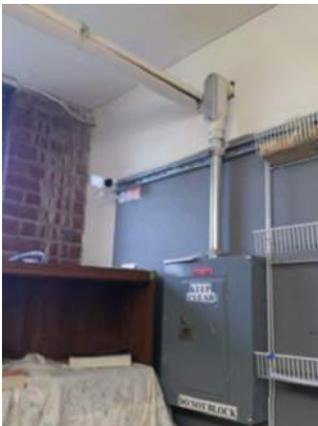
A third CCTV camera was also located in the basement hallway across from the Children's Activity Room. However this camera did not appear to be connected and was antiquated.

Consideration should be given to upgrading the CCTV system to provide additional coverage.

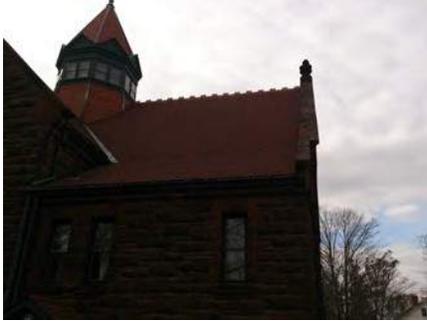
In addition to this snow melting system, a plugin type snow melting cable is installed on the roof area above the handicapped entrance. This system plugs into an exterior GFCI receptacle located near the handicapped ramp and is controlled by a time clock and switch on the interior of the building. The time clock and switch are located above the ramp snow melting system. Our office was advised during our visit that the roof snow melting system is no longer functional as the cable at the roof level had been accidentally cut.

The existing roof snow melting cable should be removed and replaced.

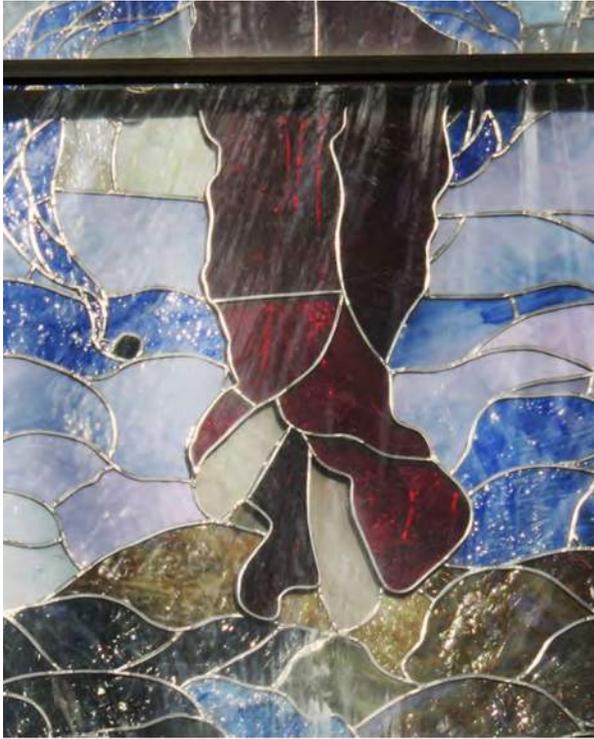
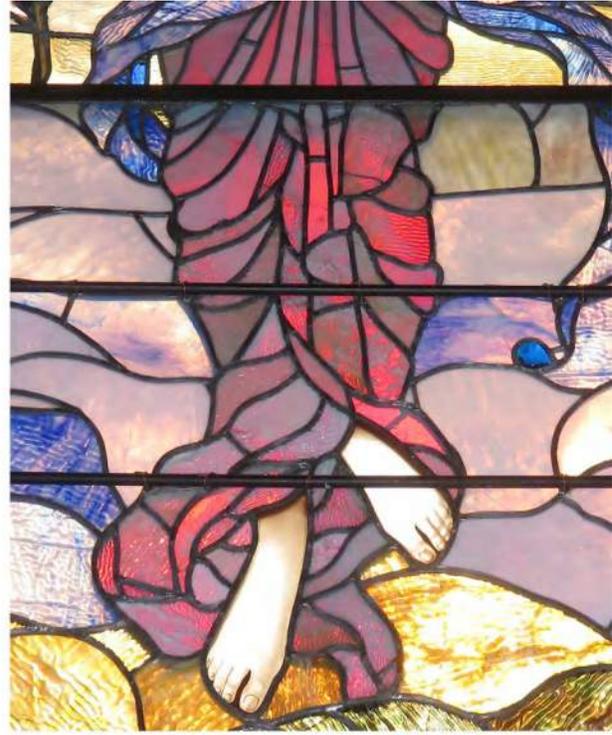
Plating

Only the figure's gown is plated with two layers of glass. On the exterior (left), is red glass that protrudes from the surface of the window. This is the plating. On the interior (right), the base layer of glass is whitish, which can be seen in reflected light, as at night when no light comes through the window. Also notice there are more pieces on the interior gown than the exterior.

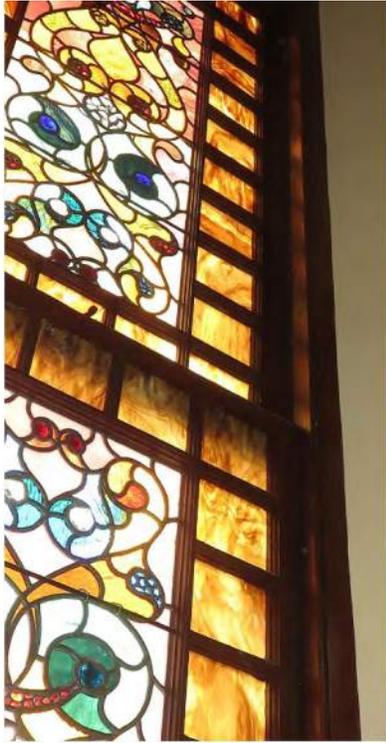
Above: In the border on each side of the figure, two of the sections are double-hung sash which no longer operates.

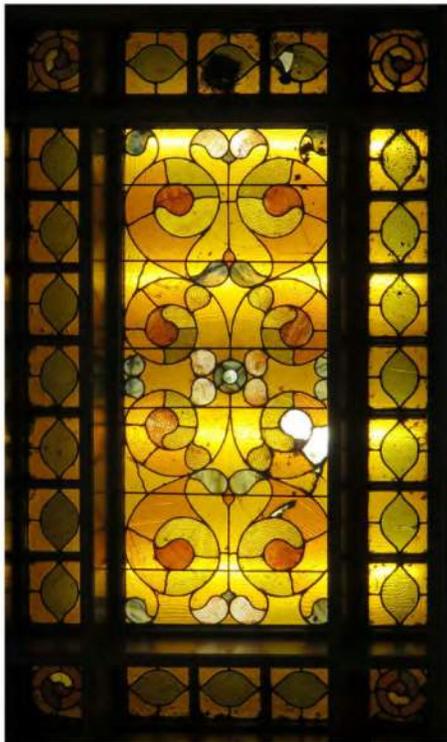
Laylight

The laylight above the circulation desk has the original lead. The Clapp Memorial window's lead came is much wider than the original came, which can be seen more clearly in the building where the two windows can be compared. During the next releading of the window (which is not required at this time), care should be taken to replace the existing came to match that in the laylight.

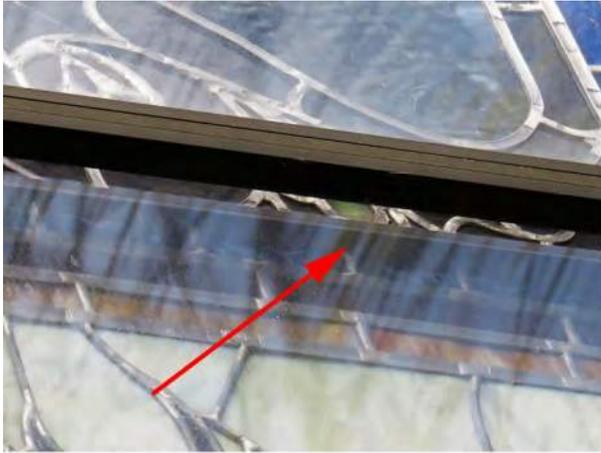
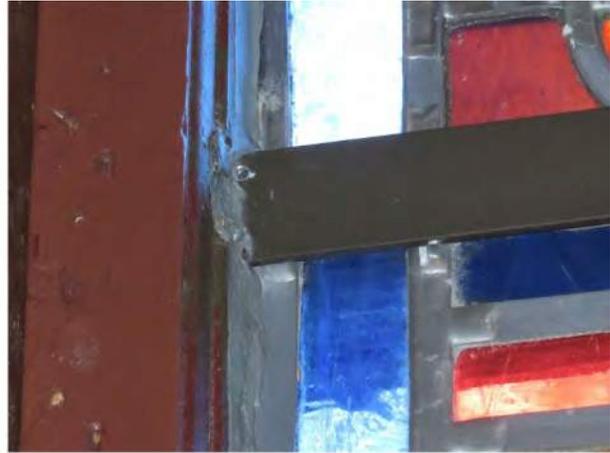
Originally the window was set either with stacked joints or with steel T-bars. These were replaced, probably in 2008, with aluminum T-bars. (The protective glazing is also set with aluminum bars.) The bars supporting the stained glass are missing their exterior snap-in molding beads (left, on the inside layer). In the photo on the right, you can see that the window is "set to daylight" with no glass catch. This means there is no glass in the frame to support the window. It appears to be held only by interior sealant (there is no exterior sealant) and the saddle bars, two of which are missing.

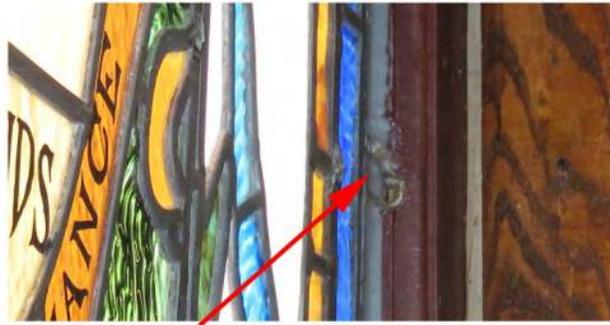
Locations of missing bars are easy to determine because the holes for them still exist in the frame.

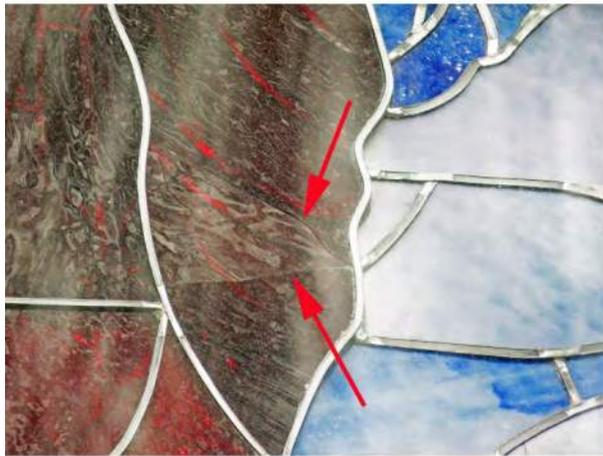
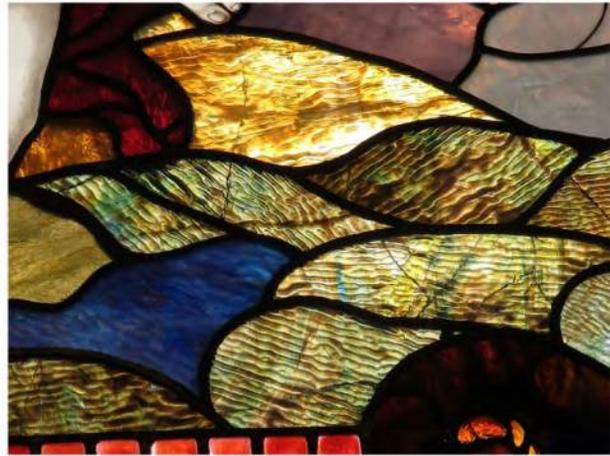
Breakage

On the left is what appears to be new breaks in the outer plating. On the right is breakage from the ceiling collapse that has been glued.

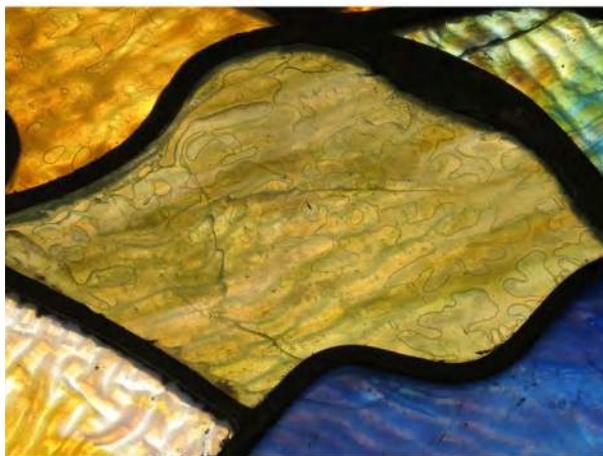
This piece was glued to a backing plate. Bubbles in the glue are clearly visible through the glass. This cannot be easily reversed.

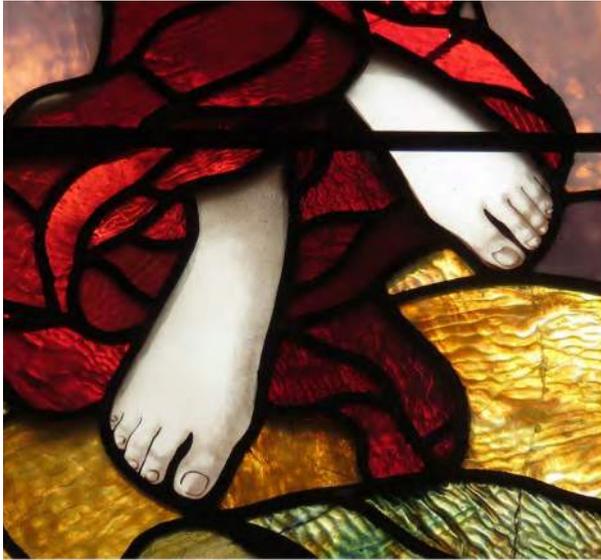
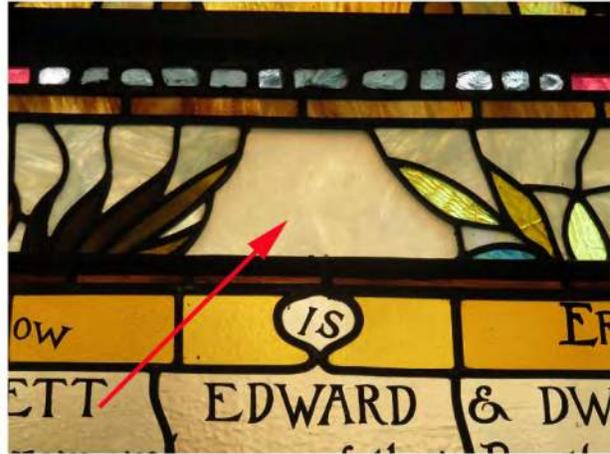
Replacement glass
A few pieces of glass were replaced in the 2008 restoration. They were well done. On the left, both of the figure's feet are new. On the right, the piece identified by the arrow is new.

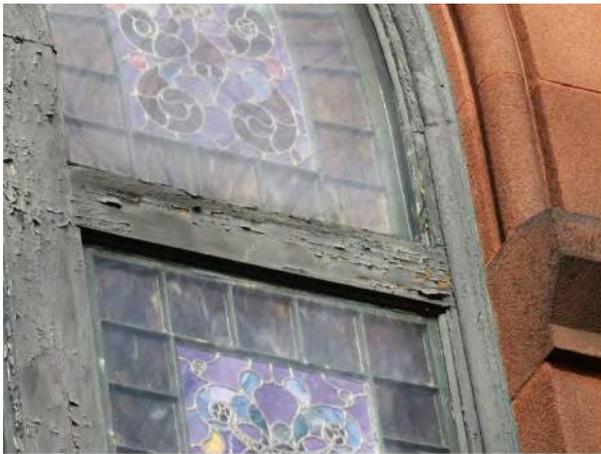
More examples of peeling paint on the frame.

The exterior of the window frame exhibits a great deal of flaking and peeling paint. This should be scraped to bare wood, primed, and repainted.
