Clapp Memorial Library

Conditions Assessment

A review of existing conditions
and prioritized recommendations for treatment
of the historic Clapp Memorial Library

July 29, 2015

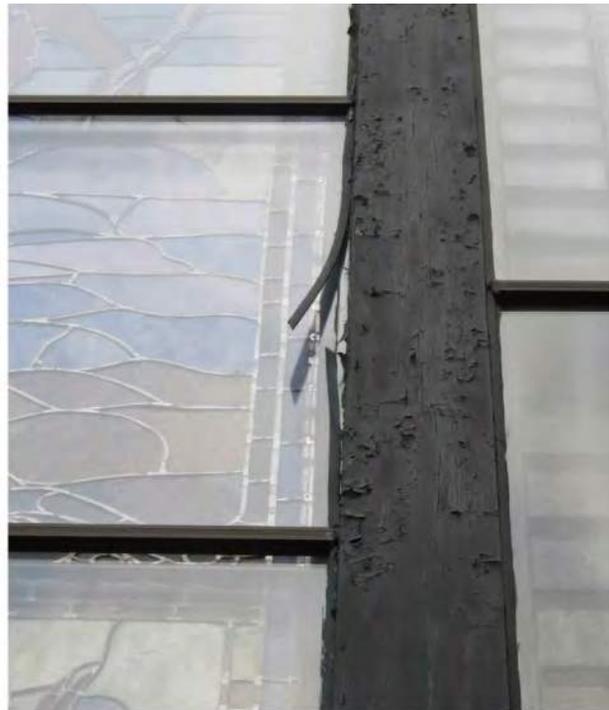
The protective glazing is held in on the side with quarter-round moldings. These are also peeling, as well as splitting and warping.

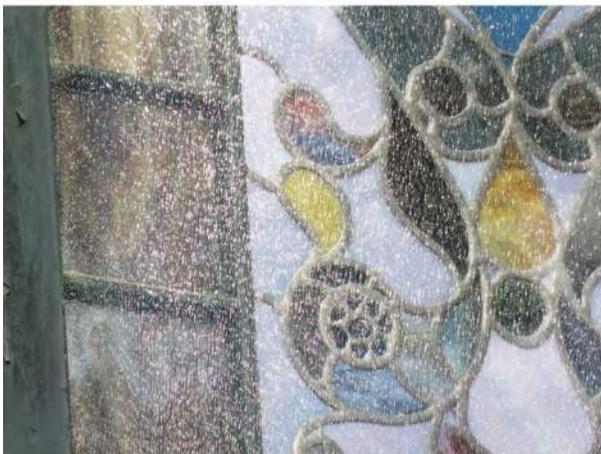
The protective glazing is plastic. It has become very crazed. It should be replaced with laminated glass.

The existing plastic glazing should be replaced with 1/4" laminated glass, affixed to the existing wood with wood moldings of sufficient size not to warp and split; or with aluminum molding sections, such as J. Sussman 200 series. There should be vent holes at the top and bottom of each independent light, and no holes on the sides.

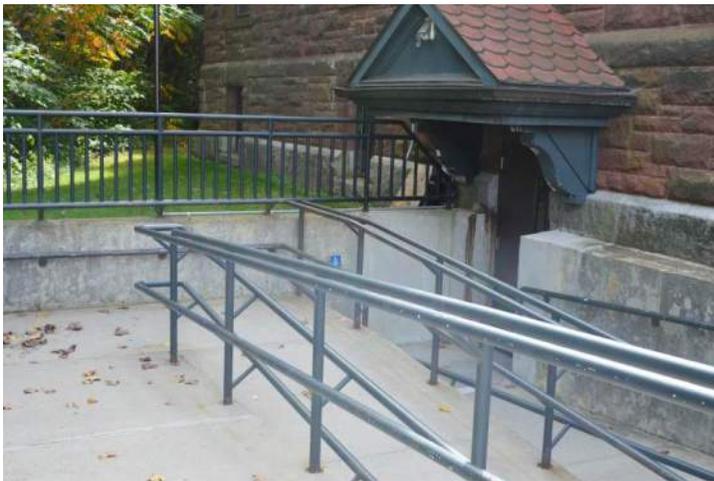
An accessible route from the parking space has been created via a ramping system to the lower level of the building.

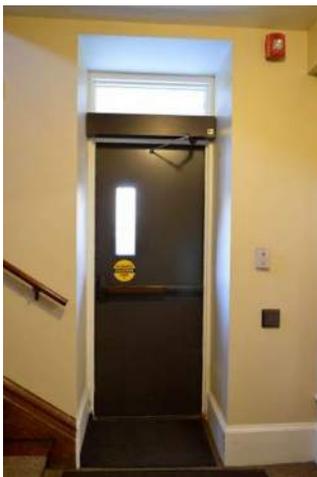
An automatic door at the base of the ramp provides access to the interior. Even as it does not meet the strict letter of the law as far as opening width, it provides access within the spirit of the law.

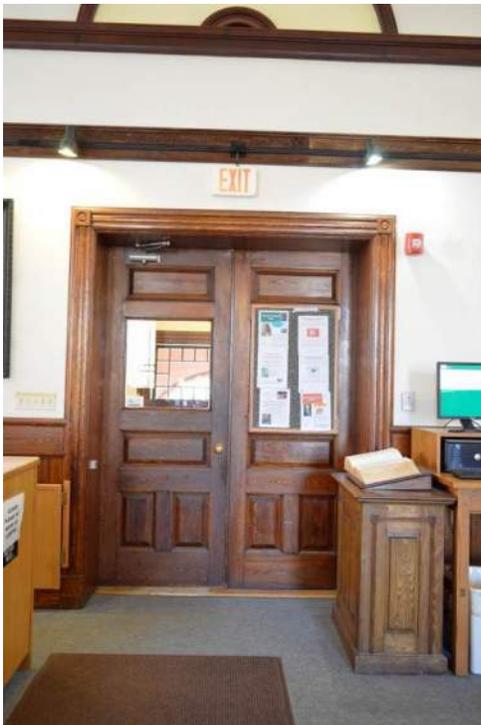
The doors at the west entrance appear to be original and show a panel configuration that accommodates a panic bar and a vision panel. The door operating hardware should include a panic bar in favor of the knob handle.

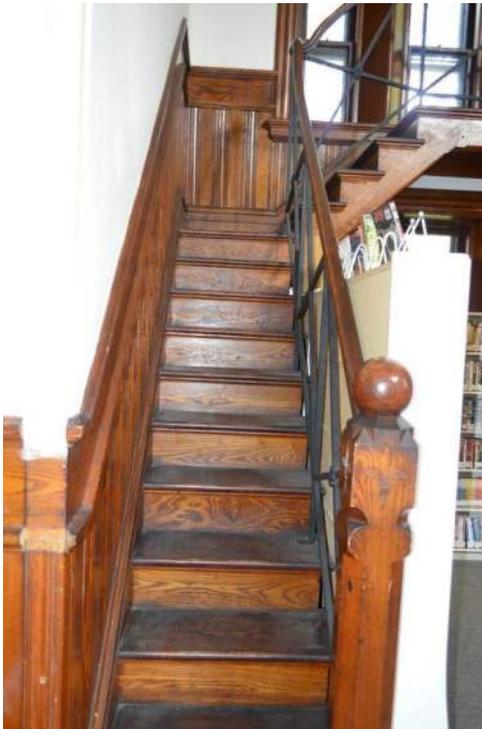
Structurally, the mezzanine level stacks require further structural assessment to determine if they can be loaded to modern standards. Unfortunately, access to the stacks is by way of a narrow, 24 inch wide staircase that is awkward to use. At present, the mezzanine stacks are modestly used for storage of library materials and are not accessible to the public. This limited storage system should remain in place with access to the mezzanine only by authorized personnel.
